DEPARTMENT OF TRANSPORTATION

Quality Assurance and Source Inspection

WELDING INSPECTION REPORT

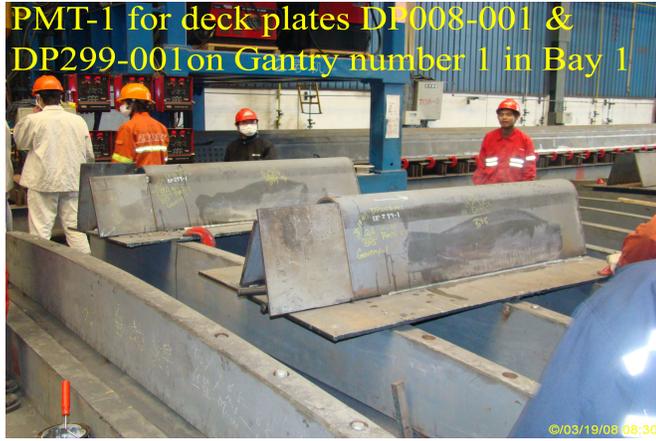
This QAI read macros for deck plates DP008 & DP299 and DP044 for a total of 23 specimens today. DP044 macro 4-2 had LOP of 3.0mm with penetration being 9.0mm being rejected and for DP008/299 macro 3-5 had a crescent shaped rust ring perpendicular to and at the end of the lack of penetration (LOP). This sample needs to be re-polished and etched to look for the existence of a possible indication in the area of rust. Macros were left arranged for the second shift QAI David Smith to photograph.
