DEPARTMENT OF TRANSPORTATION

Quality Assurance and Source Inspection

Contract #: 04-0120F4Cty: SF/ALA Rte: 80 PM: 13.2/13.9File #: 69.28**WELDING INSPECTION REPORT****Resident Engineer:** Pursell, Gary**Address:** 333 Burma Road**City:** Oakland, CA 94607**Report No:** WIR-001859**Date Inspected:** 09-Mar-2008**Project Name:** SAS Superstructure**OSM Arrival Time:** 700**Prime Contractor:** American Bridge/Fluor Enterprises, a JV**OSM Departure Time:** 1700**Contractor:** Zhenhua Port Machinery Company, Ltd (ZPMC), Changxing Island **Location:** Shanghai, China**CWI Name:** Xu Le Feng, Ye Yong Jun**CWI Present:** Yes No**Inspected CWI report:** Yes No N/A**Rod Oven in Use:** Yes No N/A**Electrode to specification:** Yes No N/A**Weld Procedures Followed:** Yes No N/A**Qualified Welders:** Yes No N/A**Verified Joint Fit-up:** Yes No N/A**Approved Drawings:** Yes No N/A**Approved WPS:** Yes No N/A**Delayed / Cancelled:** Yes No N/A**Bridge No:** 34-0006**Component:** Tower Mock-ups and OBG**Summary of Items Observed:**

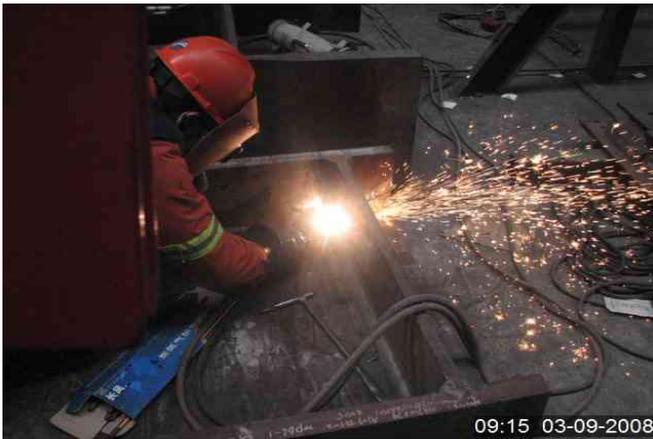
The Quality Assurance Inspector observed ZPMC excavating weld repairs utilizing the air carbon arc process without providing the minimum required preheat temperature prior to excavation on fracture critical material. The weld repairs took place at the flange to web connection on shear link beams. The surface temperature was approximately 15 degrees Celsius measured with an infra red temperature indicating device. An Incident Report was generated pertaining to the discrepancy. Below is a digital photograph illustrating the excavation in process.
