**DEPARTMENT OF TRANSPORTATION**

Contract #: 04-0120F4Cty: SF/ALA Rte: 80 PM: 13.2/13.9File #: 13.28**WELDING INSPECTION REPORT****Resident Engineer:** Pursell, Gary**Address:** 333 Burma Road**City:** Oakland, CA 94607**Report No:** WIR-001863**Date Inspected:** 02-Apr-2008**Project Name:** SAS Superstructure**OSM Arrival Time:** 700**Prime Contractor:** American Bridge/Fluor Enterprises, a JV**OSM Departure Time:** 1530**Contractor:** Oregon Iron Works Clackamas, Or.**Location:** Clackamas, Or**CWI Name:** Greg Roberts**CWI Present:** Yes No**Inspected CWI report:** Yes No N/A**Rod Oven in Use:** Yes No N/A**Electrode to specification:** Yes No N/A**Weld Procedures Followed:** Yes No N/A**Qualified Welders:** Yes No N/A**Verified Joint Fit-up:** Yes No N/A**Approved Drawings:** Yes No N/A**Approved WPS:** Yes No N/A**Delayed / Cancelled:** Yes No N/A**Bridge No:** 34-0006**Component:** Hinge K**Summary of Items Observed:**

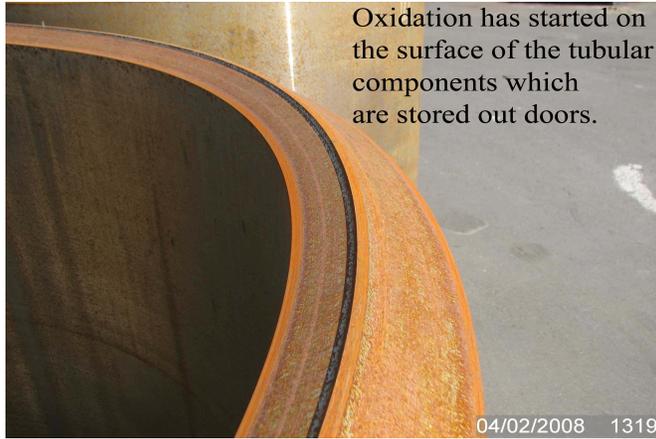
The QA Inspector observed that tubular components which have been stored in the South-West lot of Bay #8 appear to have oxidation forming on the machined surface. The QA Inspector observed that the storage of these components do not appear to be in conformance with contract documents. See photo below for additional information. The QA Inspector will inform OIW of this situation during his shift the following day.

Oxidation has started on the surface of the tubular components which are stored out doors.
