DEPARTMENT OF TRANSPORTATION

Contract #: 04-0120F4Cty: SF/ALA Rte: 80 PM: 13.2/13.9File #: 69.28**WELDING INSPECTION REPORT****Resident Engineer:** Pursell, Gary**Address:** 333 Burma Road**City:** Oakland, CA 94607**Report No:** WIR-001872**Date Inspected:** 23-Mar-2008**Project Name:** SAS Superstructure**OSM Arrival Time:** 1830**Prime Contractor:** American Bridge/Fluor Enterprises, a JV**OSM Departure Time:** 600**Contractor:** Zhenhua Port Machinery Company, Ltd (ZPMC), Changxing Island **Location:** Shanghai, China

WELDING INSPECTION REPORT

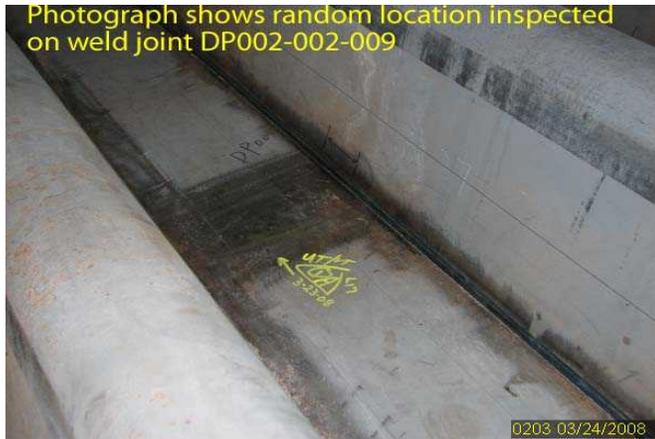
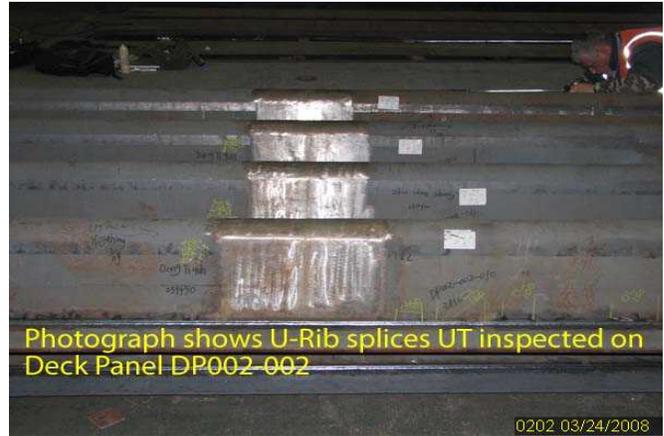
Bay 1- QA Inspector performed an Ultrasonic Test (UT) verification of U-Rib Complete Joint Penetration welds (CJP) splice welds. Each of the following U-Rib splice welds were UT inspected for a length of 300mm on each leg of the rib: DP002-002-010 thru DP002-002-013 and DP054-001-012 thru DP054-001-016. QA Inspector performed a random UT inspection on 10% of the full length of CJP splice weld on Deck Plate DP002-002. CJP splice weld number DP002-002-009 joins plates PL2D to PL2C on the Deck Panel. QA Inspector also performed a random UT inspection on 10% of the full length of CJP splice weld on Deck Plate DP054-001. CJP splice weld number DP054-001-011 joins plates PL113B to PL113D on the Deck Panel. The Ultrasonic Testing (UT) was performed to verify that 10% of the welds meet the requirements of the contract documents and AWS D1.5-2002. The weld and base metal were scanned utilizing a Krautkramer Branson USN 60. QA Inspector performed a base metal lamination check using a 25mm diameter 2.25 MHz transducer and a shear wave scans using a 20mm x 15mm 2.25 MHz transducer on a 70 degree angle wedge from face A. QA Inspector utilized Scanning patterns A, B, C, and E. For details please see the ultrasonic testing report TL-6027 dated March 23, 2008. QA Inspector found the welds inspected to be in compliance with AWS D1.5- 2002 Table 6.3 and the contract documents.
