**DEPARTMENT OF TRANSPORTATION**

Contract #: 04-0120F4Cty: SF/ALA Rte: 80 PM: 13.2/13.9File #: 69.28**WELDING INSPECTION REPORT****Resident Engineer:** Pursell, Gary**Address:** 333 Burma Road**City:** Oakland, CA 94607**Report No:** WIR-001966**Date Inspected:** 01-Apr-2008**Project Name:** SAS Superstructure**OSM Arrival Time:** 1800**Prime Contractor:** American Bridge/Fluor Enterprises, a JV**OSM Departure Time:** 730**Contractor:** Zhenhua Port Machinery Company, Ltd (ZPMC), Changxing Island **Location:** Shanghai, China

**Bridge No:** 34-0006**Component:** Tower and OBG**Summary of Items Observed:**

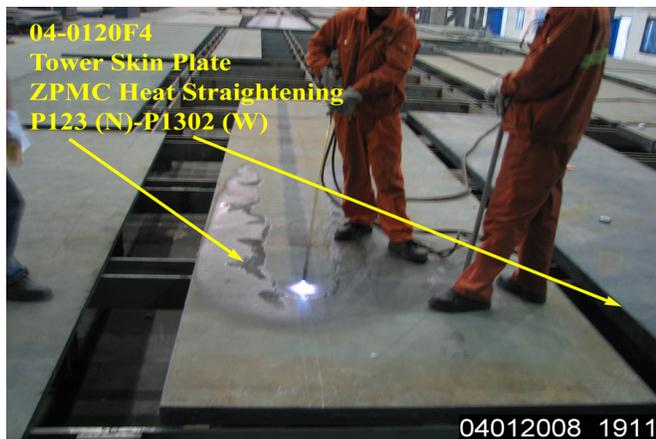
New Tower Shop: The Caltrans QA Inspector observed ZPMC performing flame heat straightening operations on tower skin plates for mill induced distortion. The tower skin plates and heat straightening procedures are identified as skin plate P123 (N)-P1302 (W), procedure HSR1 (T) 444, revision (0), skin plate P375 (E), procedure HSR1 (T)-449, revision 0 and P123 (S)-P1302 (E) procedure, HSR1 (T)-447, revision 0. Caltrans QA observed ZPMC heating the plate manually with a rose-bud torch. Caltrans QA observed ZPMC Quality Control Inspectors, Mr. Xu Le feng and Mr. Huang Shuai monitoring the heat straightening of the plates using a calibrated infra-red temperature indicating device to monitor the heat. The following digital picture illustrates heat straightening in progress.
