Contract #: 04-0120F4Cty: SF/ALA Rte: 80 PM: 13.2/13.9File #: 69.28**WELDING INSPECTION REPORT****Resident Engineer:** Pursell, Gary**Address:** 333 Burma Road**City:** Oakland, CA 94607**Report No:** WIR-002008**Date Inspected:** 14-Apr-2008**Project Name:** SAS Superstructure**OSM Arrival Time:** 2300**Prime Contractor:** American Bridge/Fluor Enterprises, a JV**OSM Departure Time:** 730**Contractor:** Zhenhua Port Machinery Company, Ltd (ZPMC), Changxing Island **Location:** Shanghai, China**CWI Name:****CWI Present:**

Bridge No: 34-0006**Component:** Tower**Summary of Items Observed:**

Caltrans Quality Assurance (QA) Inspector, Mike Hasler was present to observe the fitup, welding and related activities associated with the fabricating of Caltrans Mock-up, 77M, 89M, 114M, Orthotropic Box Girders (OBG) and Tower, for the San Francisco Oakland Bay Self Anchored Suspension Bridge, at Zhenhua Port Machinery Company (ZPMC) facility on Changxing Island.

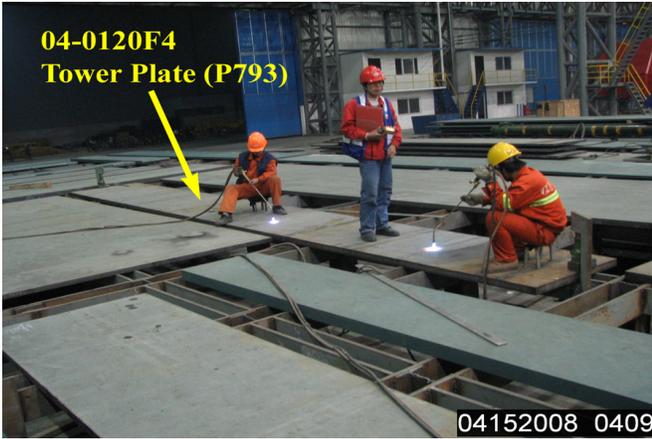
Item Description	WBS	Dwg No.	Status
1 Tower Plate	NA	NA	ZPMC Heat Straightening

New Tower Shop Bay 2: The Caltrans QA Inspector observed ZPMC performing flame heat straightening operations on tower skin plates for mill induced distortion. The tower skin plate and heat straightening procedure are identified as skin plate P793 (E), procedure HSR1 (T)-681, revision (0). Caltrans QA observed ZPMC heating the plate manually with a rose-bud torch. Caltrans QA observed ZPMC Quality Control Inspector, Mr. Lui Dao feng monitoring the heat straightening of the plate using a calibrated infra-red temperature indicating device to monitor the heat and being witnessed by ABF Inspector, Mr. Mike Williams. The following picture illustrates ZPMC heat straightening tower plate.
