DEPARTMENT OF TRANSPORTATION

Contract #: 04-0120F4Cty: SF/ALA Rte: 80 PM: 13.2/13.9File #: 69.28**WELDING INSPECTION REPORT****Resident Engineer:** Pursell, Gary**Address:** 333 Burma Road**City:** Oakland, CA 94607**Report No:** WIR-002018**Date Inspected:** 21-Apr-2008**Project Name:** SAS Superstructure**OSM Arrival Time:** 1400**Prime Contractor:** American Bridge/Fluor Enterprises, a JV**OSM Departure Time:** 2200**Contractor:** Zhenhua Port Machinery Company, Ltd (ZPMC), Changxing Island **Location:** Shanghai China**CWI Name:** See Observations below**CWI Present:** Yes No**Inspected CWI report:** Yes No N/A**Rod Oven in Use:** Yes No N/A**Electrode to specification:** Yes No N/A**Weld Procedures Followed:** Yes No N/A**Qualified Welders:** Yes No N/A**Verified Joint Fit-up:** Yes No N/A**Approved Drawings:** Yes No N/A**Approved WPS:** Yes No N/A**Delayed / Cancelled:** Yes No N/A**Bridge No:** 34-0006**Component:** OBG side panels & Tower skin plates**Summary of Items Observed:**

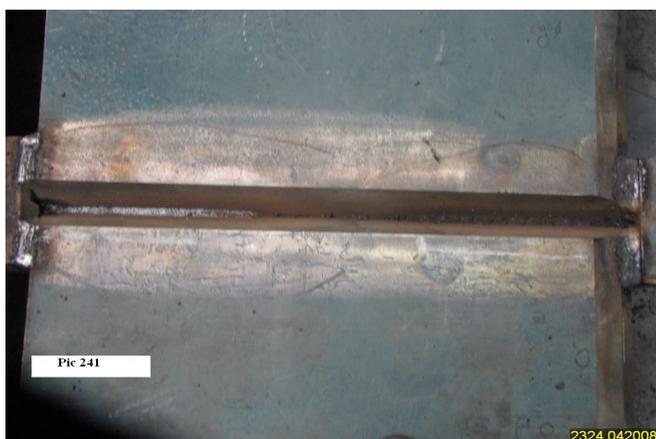
Item Description	WBS	Dwg No.	Status
1 Pic 241 Weld#216 SA216A/K-17B showing SMAW tack weld of joint root and in-process of cleaning tack pass			
2 Pic 242

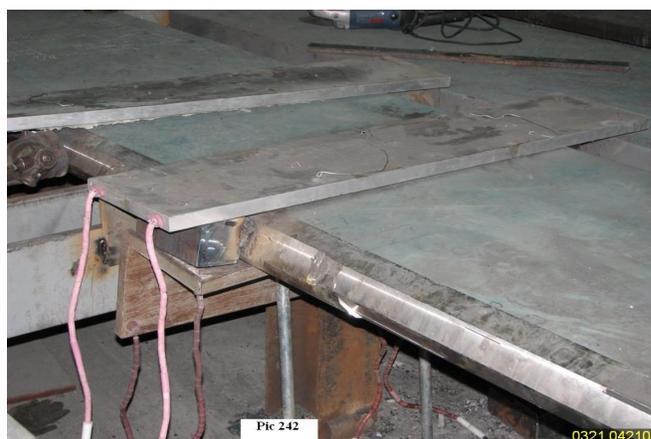
Typical pre-heating using thermal panels on weld #216 100mm thick skin plates.
