DEPARTMENT OF TRANSPORTATION

Quality Assurance and Source Inspection

Contract #: 04-0120F4Cty: SF/ALA Rte: 80 PM: 13.2/13.9File #: 69.28**WELDING INSPECTION REPORT****Resident Engineer:** Pursell, Gary**Address:** 333 Burma Road**City:** Oakland, CA 94607**Report No:** WIR-002074**Date Inspected:** 05-Apr-2008**Project Name:** SAS Superstructure**OSM Arrival Time:** 600**Prime Contractor:** American Bridge/Fluor Enterprises, a JV**OSM Departure Time:** 1730**Contractor:** Zhenhua Port Machinery Company, Ltd (ZPMC), Changxing Island **Location:** Shanghai China

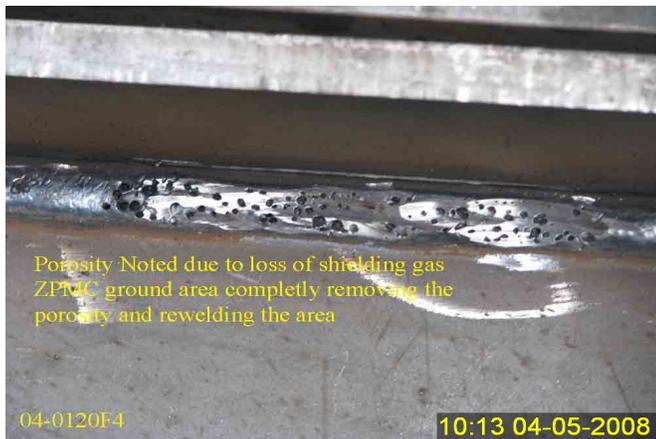
During the welding of floor beam number FB021-02-128 ZPMC welder Zhang Qing Quan's lost his gas shielding for the dual shielding which produced area porosity approximately 300 mm in length (see digital photo below). This QA inspector observed ZPMC personnel grind the area until no visible porosity was noted and then re weld the area with no more porosity present. This QA inspector witnessed ZPMC start a Critical Weld Repair (CWR) number B-CWR 40 for floor beam FB008-05 which had 6 crack locations. ZPMC preheated the areas to the required temperatures as according to the CWR of 65°C prior to the Carbon arc gouging process. Once completed ZPMC then ground the areas to a bright finish in the excavated areas and it was observed by this QA inspector that it appeared that the cracks were removed. ZPMC informed this QA inspector that they would be performing
