DEPARTMENT OF TRANSPORTATION

Contract #: 04-0120F4Cty: SF/ALA Rte: 80 PM: 13.2/13.9File #: 69.28**WELDING INSPECTION REPORT****Resident Engineer:** Pursell, Gary**Address:** 333 Burma Road**City:** Oakland, CA 94607**Report No:** WIR-002103**Date Inspected:** 24-Mar-2008**Project Name:** SAS Superstructure**OSM Arrival Time:** 630**Prime Contractor:** American Bridge/Fluor Enterprises, a JV**OSM Departure Time:** 1730**Contractor:** Zhenhua Port Machinery Company, Ltd (ZPMC), Changxing Island **Location:** Shanghai, China

WELDING INSPECTION REPORT

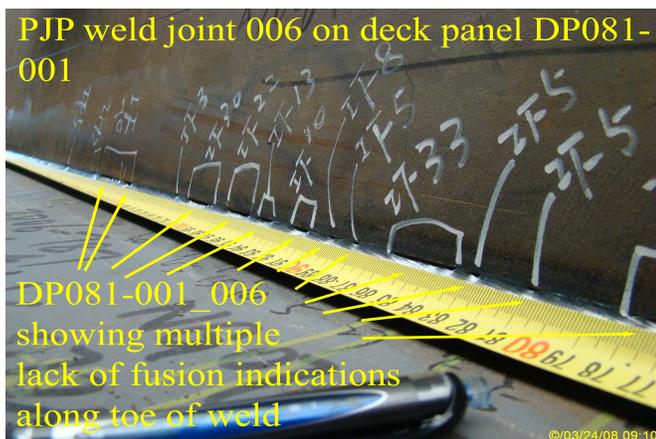
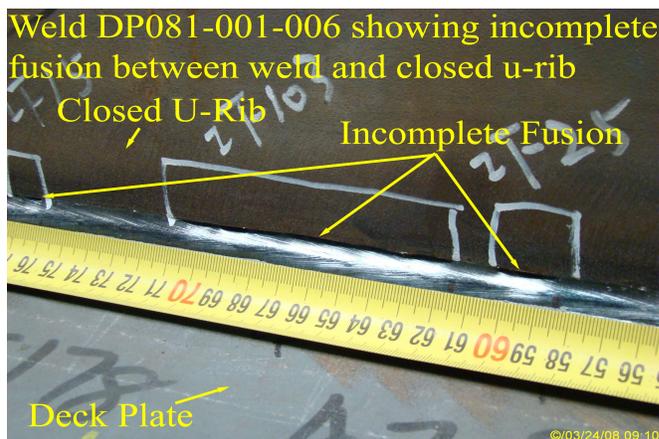
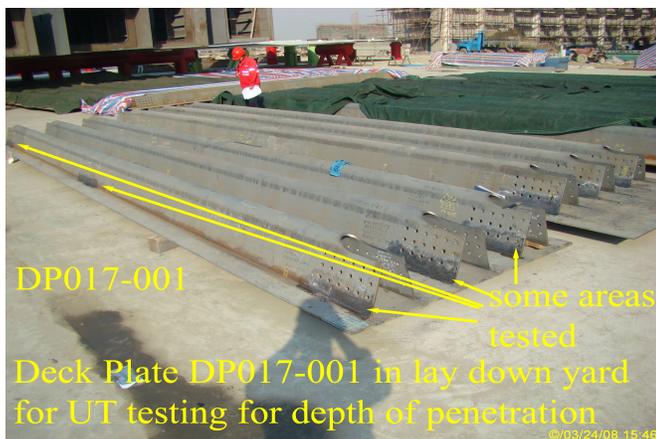
This Quality Assurance Inspector (QAI) performed visual testing (VT) of deck panel DP081-001 weld joints 004, 005 & 006 on u-ribs U89 & U27. The welds were 14970 millimeter long and weld 004 weld over lap (OL), under fill (UF) and lack of fusion (LOF). Weld joint 005 had OL, UF & LOF and weld 006 had UF & LOF. Results were reported on the Caltrans QA Visual Weld Inspection Report for the OBG Deck Panels with a copy being submitted to the Assistant Structural Materials Representative (ASMR) Ady Velasco.
