**DEPARTMENT OF TRANSPORTATION**

Contract #: 04-0120F4Cty: SF/ALA Rte: 80 PM: 13.2/13.9File #: 69.28**WELDING INSPECTION REPORT****Resident Engineer:** Pursell, Gary**Address:** 333 Burma Road**City:** Oakland, CA 94607**Report No:** WIR-002114**Date Inspected:** 24-Apr-2008**Project Name:** SAS Superstructure**OSM Arrival Time:** 2300**Prime Contractor:** American Bridge/Fluor Enterprises, a JV**OSM Departure Time:** 730**Contractor:** Zhenhua Port Machinery Company, Ltd (ZPMC), Changxing Island **Location:** Changxing Island**CWI Name:** Li Yan Hua**CWI Present:** Yes No**Inspected CWI report:** Yes No N/A**Rod Oven in Use:** Yes No N/A**Electrode to specification:** Yes No N/A**Weld Procedures Followed:** Yes No N/A**Qualified Welders:** Yes No N/A**Verified Joint Fit-up:** Yes No N/A**Approved Drawings:** Yes No N/A**Approved WPS:** Yes No N/A**Delayed / Cancelled:** Yes No N/A**Bridge No:** 34-0006**Component:** Tower and OBG**Summary of Items Observed:**

# WELDING INSPECTION REPORT

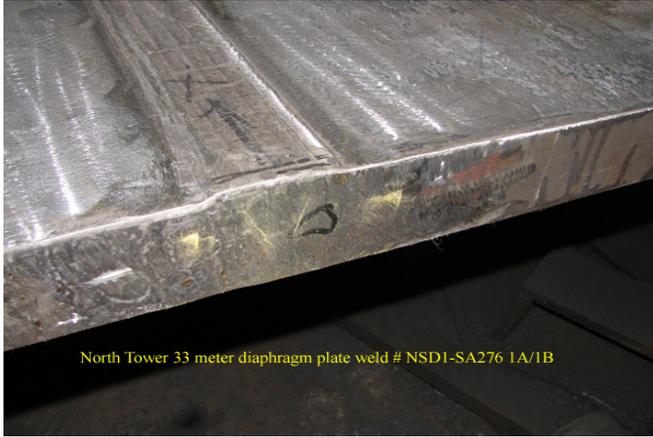
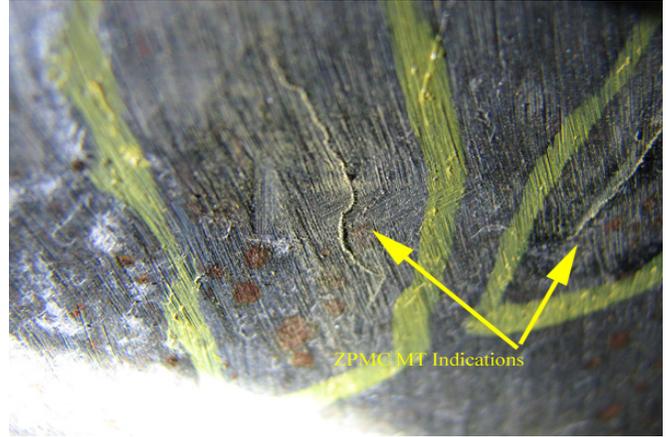
The Caltrans QA Inspector was scheduled perform Magnetic Particle Testing (MT) verification of the 33 Meter Diaphragm bottom plate weld NSD1-SA276 1A, 1B, 2A, and 2B. Upon arrival there were no markings to indicate whether the weld was acceptable. Linear cracks were found on both ends of the diaphragm plate with yellow magnetic powder present. Two cracks of 20 and 30 mm were found on weld 1A and two cracks measuring 15 mm each were found on weld 2A and 2B. The cracks observed were shown to ZPMC QC Mr. Li Xiuyang. Mr. Xiuyang consulted with ZPMC a ZPMC MT technician and stated that the MT was not complete and the area of cracking at the weld termination was scheduled to be machined and that the area would be retested by ZPMC QC. Please see the photos below of the diaphragm cracking.
