DEPARTMENT OF TRANSPORTATION

Contract #: 04-0120F4Cty: SF/ALA Rte: 80 PM: 13.2/13.9File #: 69.28**WELDING INSPECTION REPORT****Resident Engineer:** Pursell, Gary**Address:** 333 Burma Road**City:** Oakland, CA 94607**Report No:** WIR-002231**Date Inspected:** 12-May-2008**Project Name:** SAS Superstructure**OSM Arrival Time:** 1400**Prime Contractor:** American Bridge/Fluor Enterprises, a JV**OSM Departure Time:** 2300**Contractor:** Zhenhua Port Machinery Company, Ltd (ZPMC), Changxing Island **Location:** Shanghai, China

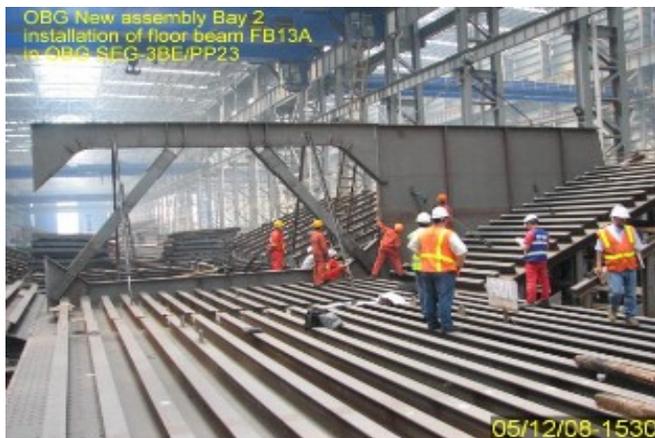
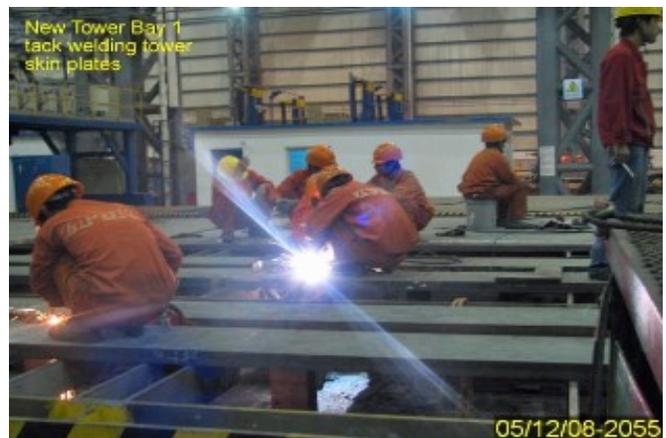
QA observed ZPMC qualified welding personnel perform SAW on one side of the groove weld joining tower skin plates, weld# WSD1-SA107B/T-17B and WSD1-SA107B/T-16B following the guide lines of approved WPS# WPS-B-T-2221-B-U3c-S and WPS-B-T-2221-B-U3c-S-1. QA observed 3 ZPMC Quality Control (QC) inspectors in the vicinity of the welding operations including ZPMC CWI identified as An Qingxiang. There was also 1 American Bridge/Fluor (ABF) QC inspector in the area as well. QC monitored the welding process continuously throughout the evening. The welding parameters as measured with Quality Controls calibrated instruments appeared to be in conformance with the posted WPS's and were as follows:

Other general observations in the New Tower bays include ZPMC tack welding tower skin plates, weld bevel preparation, flame straightening, CNC parts cutting and grinding.
