DEPARTMENT OF TRANSPORTATION

Contract #: 04-0120F4Cty: SF/ALA Rte: 80 PM: 13.2/13.9File #: 69.28**WELDING INSPECTION REPORT****Resident Engineer:** Pursell, Gary**Address:** 333 Burma Road**City:** Oakland, CA 94607**Report No:** WIR-002256**Date Inspected:** 02-May-2008**Project Name:** SAS Superstructure**OSM Arrival Time:** 1730**Prime Contractor:** American Bridge/Fluor Enterprises, a JV**OSM Departure Time:** 730**Contractor:** Zhenhua Port Machinery Company, Ltd (ZPMC), Changxing Island **Location:** Shanghai, China**CWI Name:** Xu Le Feng**CWI Present:** Yes No**Inspected CWI report:** Yes No N/A**Rod Oven in Use:** Yes No N/A**Electrode to specification:** Yes No N/A**Weld Procedures Followed:** Yes No N/A**Qualified Welders:** Yes No N/A**Verified Joint Fit-up:** Yes No N/A**Approved Drawings:** Yes No N/A**Approved WPS:** Yes No N/A**Delayed / Cancelled:** Yes No N/A**Bridge No:** 34-0006**Component:** Tower**Summary of Items Observed:**

Caltrans Quality Assurance (QA) Inspector, Mike Hasler was present to observe the fitup, welding and related activities associated with the fabricating of Caltrans Mock-up, 77M, 89M, 114M, Orthotropic Box Girders (OBG) and Tower, for th

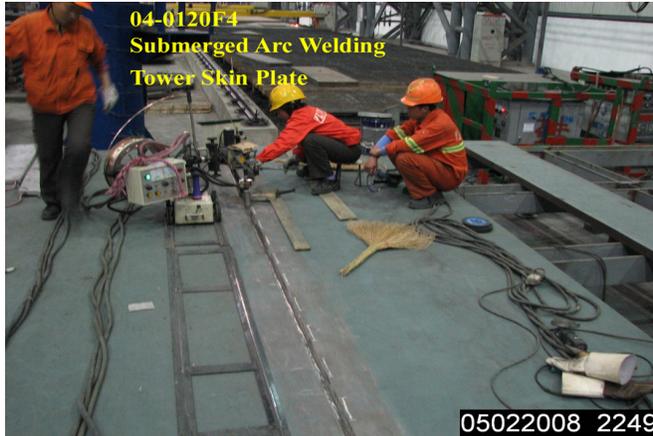
Item	Description	WBS	Dwg No.	Status
1	Tower Skin Plate	NA	NA	Welding
<p>New Tower Shop Bay 2: Caltrans QA Inspector observed ZPMC performing submerged arc welding (SAW), tower skin plate P850 (E) joining P1568 (E), root pass weld. The weld is identified as ESD1-SA77 A/E- 43B, complete joint penetration (CJP). The welder operator is identified as Ms. Shen Mei, welder stamp 041716, utilizing welding procedures WPS-B-T-2221-B-U3c-S-1. Caltrans QA measured current welding parameters at approximately 515 amps, 29.0 volts and 455mm/min (millimeters per minute) travel speed. Caltrans QA verified preheat and interpass temperatures during the welding of ASTM 709M, Grade 345F2 type materials, 60mm joining 60mm thicknesses. The preheat temperature prior to the start of welding measures more than 110 degrees Celsius but less than 230 degrees Celsius during maximum interpass temperature verification. Caltrans QA observed ZPMC QC/CWI inspector, Mr. Xu Le Feng monitoring the activities at the work station. The following digital picture illustrates welding in progress.</p>

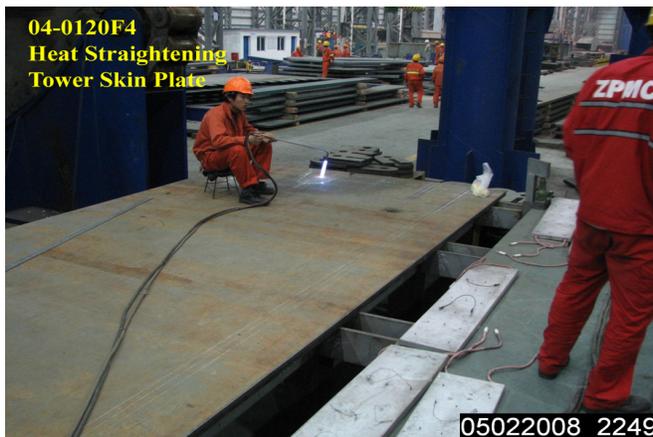
- 3 Tower Skin Plate NA NA Heat Straightening

New Tower Shop Bay 2: Caltrans QA ZPMC performing flame heat straightening operations on tower skin plate for mill induced distortion. The tower skin plate and heat straightening procedure are identified as skin plate P853 (W), procedure HSR1 (T)-1235, revision (0). Caltrans QA observed ZPMC heating the plate manually with a rose-bud torch. Caltrans QA observed ZPMC Quality Control Inspector, Mr. Yang Bai Qiang monitoring the heat straightening of the plate using a calibrated infra-red temperature indicating device to monitor the heat. The following digital picture illustrates ZPMC heat straightening in progress.
