DEPARTMENT OF TRANSPORTATION

Contract #: 04-0120F4Cty: SF/ALA Rte: 80 PM: 13.2/13.9File #: 69.28**WELDING INSPECTION REPORT****Resident Engineer:** Pursell, Gary**Address:** 333 Burma Road**City:** Oakland, CA 94607**Report No:** WIR-002281**Date Inspected:** 04-May-2008**Project Name:** SAS Superstructure**OSM Arrival Time:** 630**Prime Contractor:** American Bridge/Fluor Enterprises, a JV**OSM Departure Time:** 1530**Contractor:** Zhenhua Port Machinery Company, Ltd (ZPMC), Changxing Island **Location:** Shanghai, China**CWI Name:** Fu Yu Hong**CWI Present:** Yes No**Inspected CWI report:** Yes No N/A**Rod Oven in Use:** Yes No N/A**Electrode to specification:** Yes No N/A**Weld Procedures Followed:** Yes No N/A**Qualified Welders:** Yes No N/A**Verified Joint Fit-up:** Yes No N/A**Approved Drawings:** Yes No N/A**Approved WPS:** Yes No N/A**Delayed / Cancelled:** Yes No N/A**Bridge No:** 34-0006**Component:** OBG Deck panels**Summary of Items Observed:**

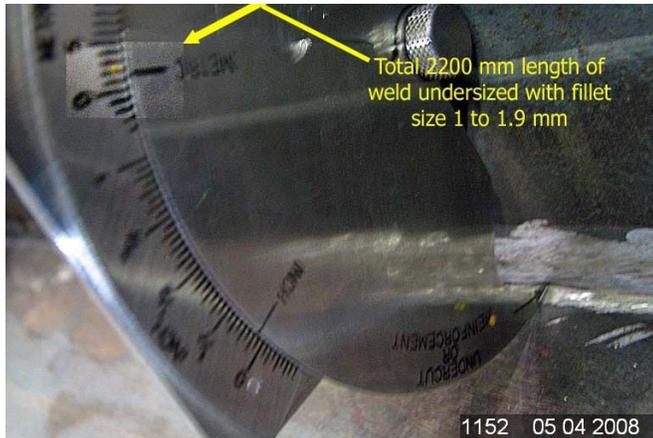
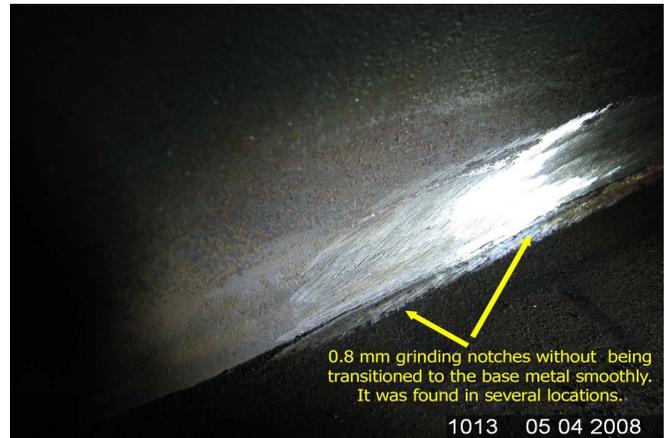
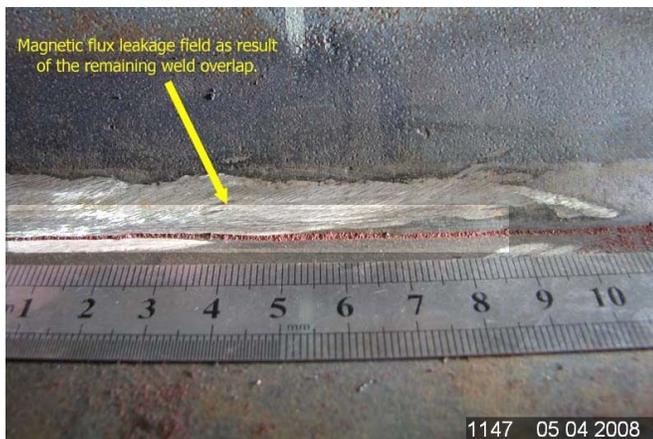
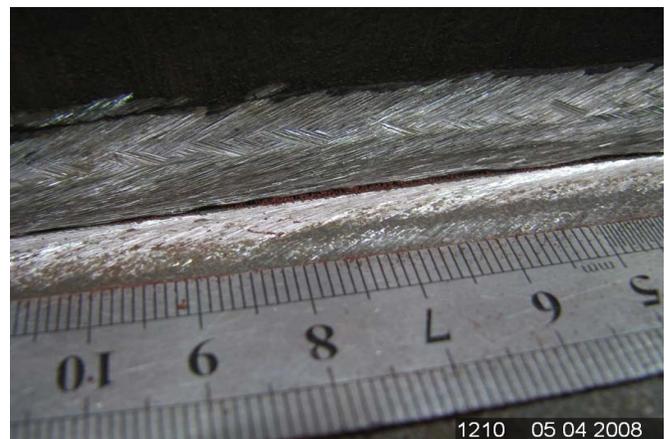
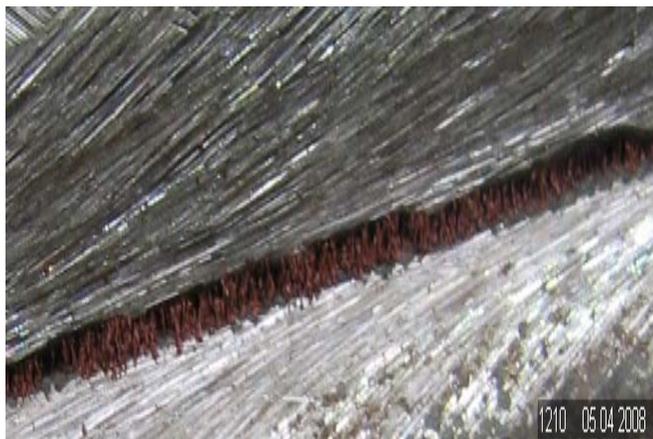
The QA inspector performed visual weld inspection to the deck panels DP-059-001 welds 1 thru 8 after ZPMC completed the visual and magnetic particle inspections. The QA inspector found weld discontinuities identified as overlap, undersize welds and notches at the toe of the weld caused by the grinding operations. In addition, the QA inspector performed magnetic particle inspection (MT) and found a flux leakage from the corner from the remaining overlap. The QA inspector had a conversation with ABF representative Warren Buehler. The QA inspector showed the areas in question. ABF agreed, however, Mr. Warren Buehler found 2 mm as fillet weld size with the ZPMC and ABF's bridge cam gages on the areas identified as undersized. The QA inspector compared the gages and the tip of the bridge cam gages from ZPMC and ABF and observed that the tips of the gages were dull and rounder. In this particular case, ZPMC could not measure with accuracy the weld size of the partial penetration weld (inside the cavities present from the weld overlap). Mr. Warren Buehler said that he could not reject the weld as weld undersize because ZPMC and ABF were measuring 2 mm regardless. He added that the weld still was overlapped anyway and need it to be perform additional grinding on the toes of the weld which it was going to lead to weld undersize. ZPMC agreed to repair. See photograph below.
