DEPARTMENT OF TRANSPORTATION

Contract #: 04-0120F4Cty: SF/ALA Rte: 80 PM: 13.2/13.9File #: 69.28**WELDING INSPECTION REPORT****Resident Engineer:** Pursell, Gary**Address:** 333 Burma Road**City:** Oakland, CA 94607**Report No:** WIR-002308**Date Inspected:** 11-May-2008**Project Name:** SAS Superstructure**OSM Arrival Time:** 2300**Prime Contractor:** American Bridge/Fluor Enterprises, a JV**OSM Departure Time:** 800**Contractor:** Zhenhua Port Machinery Company, Ltd (ZPMC), Changxing Island **Location:** Changxing Island**CWI Name:** Chen Xi**CWI Present:** Yes No**Inspected CWI report:** Yes No N/A**Rod Oven in Use:** Yes No N/A**Electrode to specification:** Yes No N/A**Weld Procedures Followed:** Yes No N/A**Qualified Welders:** Yes No N/A**Verified Joint Fit-up:** Yes No N/A**Approved Drawings:** Yes No N/A**Approved WPS:** Yes No N/A**Delayed / Cancelled:** Yes No N/A**Bridge No:** 34-0006**Component:** OBG**Summary of Items Observed:**

Caltrans Quality Assurance (QA) Inspector, Larry Viars was present to perform Visual Testing (VT) of the Orthotropic Box Girder (OBG) components, for the San Francisco Oakland Bay Self Anchored Suspension Bridge, at Zhenhua Port Machinery C

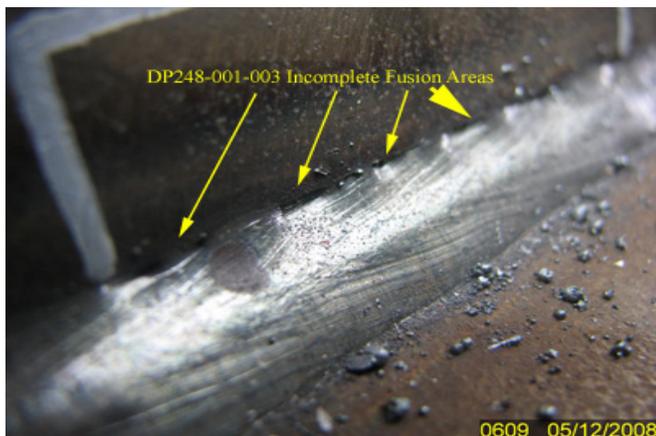
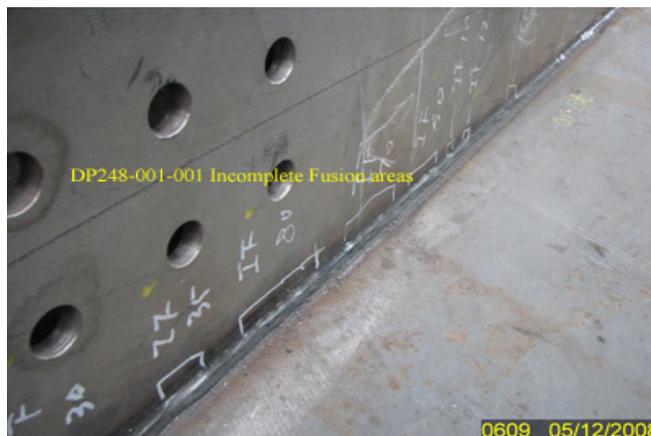
The Caltrans QA Inspector performed visual inspection of OBG 19.955 meter deck panel DP248-001 (welds 002 through 010) U-rib Partial Joint Penetration (PJP) welds. Visual testing of welding was performed in accordance with contract documents. The following discontinuities were found during inspection on the Submerged Arc Welding (SAW) cover pass, incomplete fusion, overlap, undercut, underfill and oversize welds. Welding discontinuities were marked on deck panel with a permanent marker, length and Y location recorded. Visual Inspection results were distributed to the appropriate personnel for review. A summary of discontinuities on inspected U- rib PJP welds are listed below. Please see the attached photo below of discontinuities found during visual inspection.

DP248-001-002, Incomplete Fusion 1 area and, Underfill 26 areas

DP248-001-003, Underfill 22 areas, Incomplete Fusion 31 areas, Oversize 3 areas, and Undercut 2 areas

DP248-001-004, Underfill 25 areas, Incomplete Fusion 1 area, and Oversize 1 area

DP248-001-005, Underfill 31 areas, Incomplete Fusion 2 areas, and Oversize 1 area

DP248-001-006, Underfill 13 areas, and Incomplete Fusion 2 areas

DP248-001-007, Underfill 25 areas, and Incomplete Fusion 2 areas

DP248-001-008, Underfill 15 areas, Incomplete Fusion 16 areas, Undercut 1 area, and Oversize 1 area

DP248-001-009, Underfill 27 areas, and Undercut 1 areas

DP248-001-010, Underfill 12 areas, and Incomplete Fusion 12 areas
