**DEPARTMENT OF TRANSPORTATION**

Contract #: 04-0120F4Cty: SF/ALA Rte: 80 PM: 13.2/13.9File #: 69.28**WELDING INSPECTION REPORT****Resident Engineer:** Pursell, Gary**Address:** 333 Burma Road**City:** Oakland, CA 94607**Report No:** WIR-002349**Date Inspected:** 26-Apr-2008**Project Name:** SAS Superstructure**OSM Arrival Time:** 630**Prime Contractor:** American Bridge/Fluor Enterprises, a JV**OSM Departure Time:** 1530**Contractor:** Zhenhua Port Machinery Company, Ltd (ZPMC), Changxing Island **Location:** Shanghai, China**CWI Name:** Fu Yu Hong**CWI Present:** Yes No**Inspected CWI report:** Yes No N/A**Rod Oven in Use:** Yes No N/A**Electrode to specification:** Yes No N/A**Weld Procedures Followed:** Yes No N/A**Qualified Welders:** Yes No N/A**Verified Joint Fit-up:** Yes No N/A**Approved Drawings:** Yes No N/A**Approved WPS:** Yes No N/A**Delayed / Cancelled:** Yes No N/A**Bridge No:** 34-0006**Component:** OBG and Tower**Summary of Items Observed:**

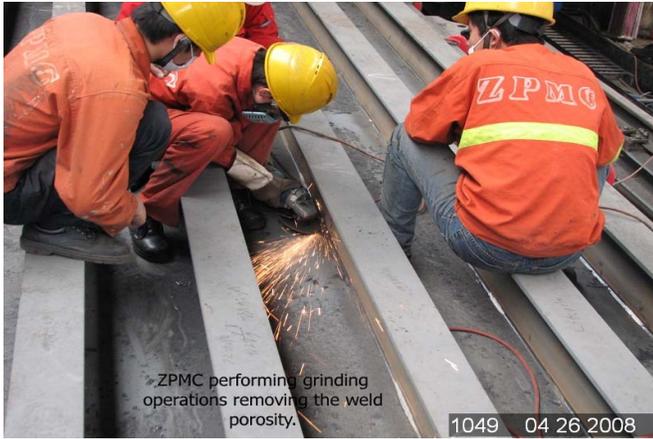
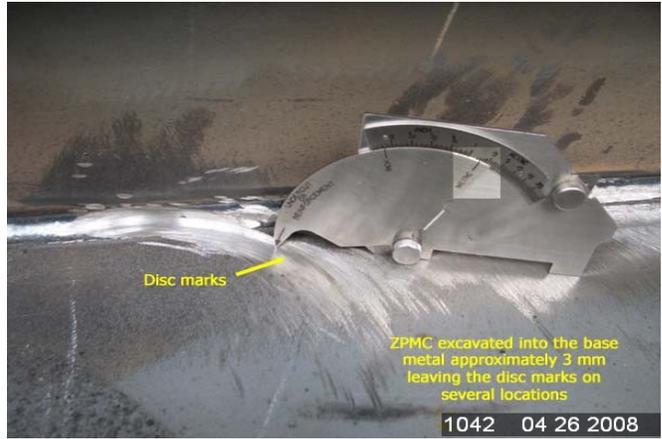
The QA inspector observed ZPMC performing welding operations at the side plate SP753-001 joint # 037 thru 042 after completing welding operations with flux cored arc welding with the gantry machine in bay # 3. The QA inspector observed ZPMC removing weld porosity by grinding. The QA inspector observed that ZPMC was excavating the base metal of the side plate with grinding disc. See digital photograph below. The QA Inspector had a conversation with ZPMC and ABF representatives Mr. Lu Xianying, Mr. Wu Ming Kai and Kevin Dye. The QA inspector informed ZPMC and ABF representatives that ZPMC was grinding into the base metal excavating approximately 3 mm and then producing unnecessary base metal weld repair in several locations. ZPMC and ABF representative agreed and Mr. Kevin Dye informed to the QA inspector that he was going to write an internal incident report addressing this condition. The QA inspector informed Task Leader Craig Hager about ZPMC to perform to repair porosity on the weld.

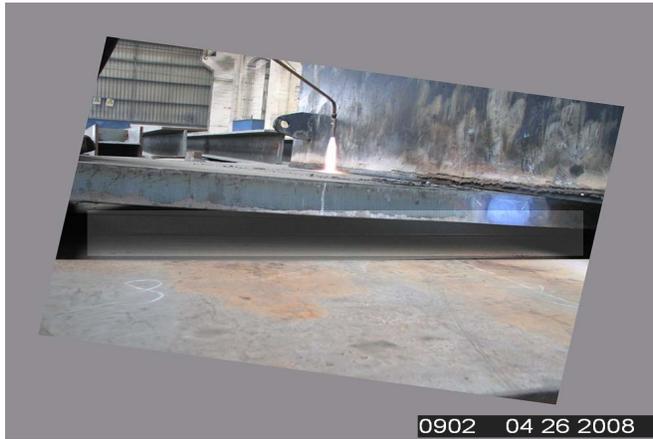
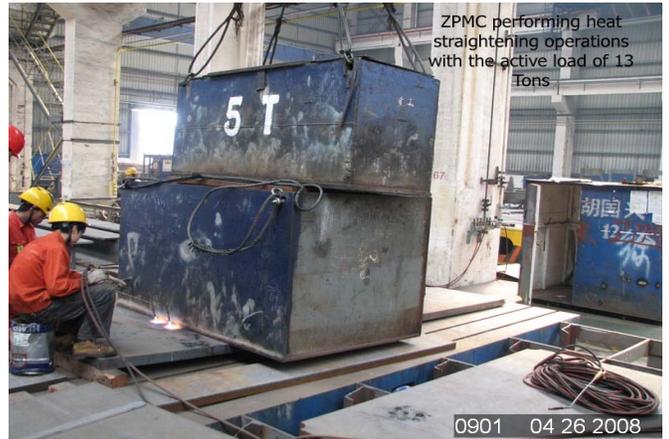
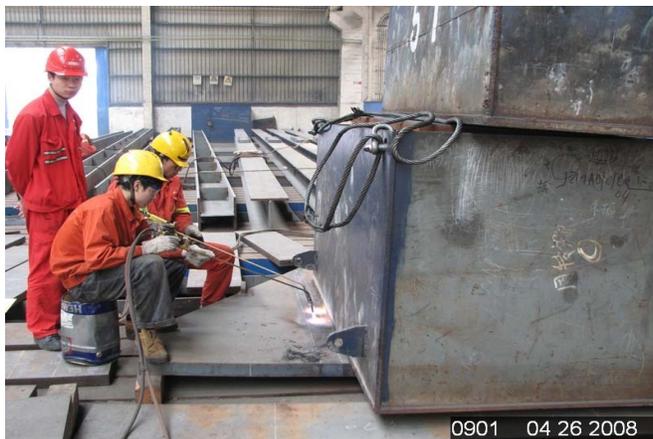
1	<p>ZPMC Heat Straightening HSR-(1) 583</p> <p>The QA inspector observed ZPMC in Bay # 8 performing heat straightening operations at the diaphragm from the 38 meters elevations at the Top diaphragm plate 196N for lift 1 using the HRS1(T)583. ZPMC located a 13 ton active load applied to one end of the diaphragm plate with the opposite side being elevated. Digital pictures of this heat straightening method were sent to the SMR for review.</p>			
---	---	--	--	--

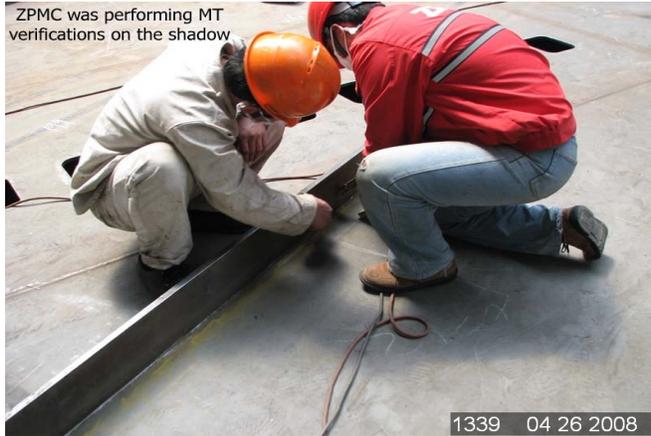
The QA inspector observed QC inspector Wang Wei performing magnetic particle testing (MT) at the junction of floor beam to stiffeners FB-013-007 weld joint 002 without using a flash light on the shadow. See photograph below. The QA inspector had a conversation of Mr. Wang Wei the QA inspector recommended to use a flash light. ZPMC QC inspector informed that he uses the flash light when he needs. However he was going to start helping his weld visual examination with the flash light.
