DEPARTMENT OF TRANSPORTATION

Contract #: 04-0120F4Cty: SF/ALA Rte: 80 PM: 13.2/13.9File #: 13.28**WELDING INSPECTION REPORT****Resident Engineer:** Pursell, Gary**Address:** 333 Burma Road**City:** Oakland, CA 94607**Report No:** WIR-002398**Date Inspected:** 08-May-2008**Project Name:** SAS Superstructure**OSM Arrival Time:** 700**Prime Contractor:** American Bridge/Fluor Enterprises, a JV**OSM Departure Time:** 1200**Contractor:** Oregon Iron Works Clackamas, Or.**Location:** Clackamas, OR**CWI Name:** Greg Roberts**CWI Present:** Yes No**Inspected CWI report:** Yes No N/A**Rod Oven in Use:** Yes No N/A**Electrode to specification:** Yes No N/A**Weld Procedures Followed:** Yes No N/A**Qualified Welders:** Yes No N/A**Verified Joint Fit-up:** Yes No N/A**Approved Drawings:** Yes No N/A**Approved WPS:** Yes No N/A**Delayed / Cancelled:** Yes No N/A**Bridge No:** 34-0006**Component:** Hinge K fuse overlay mockup**Summary of Items Observed:**

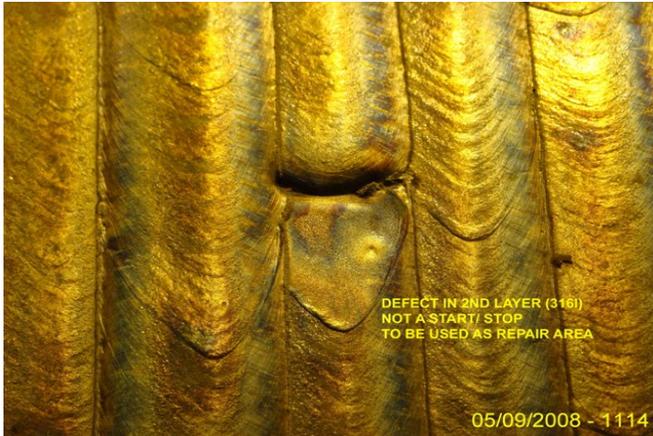
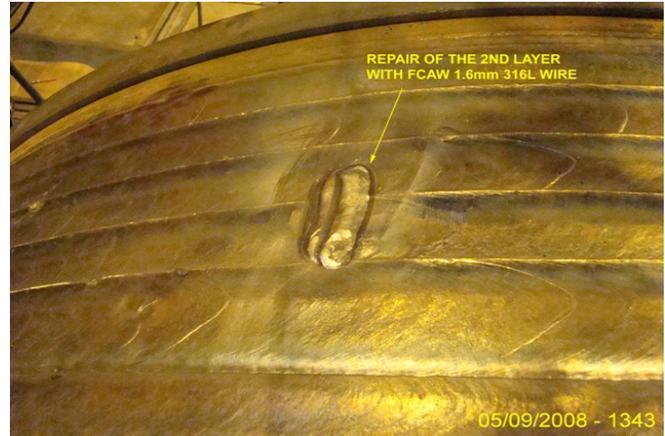
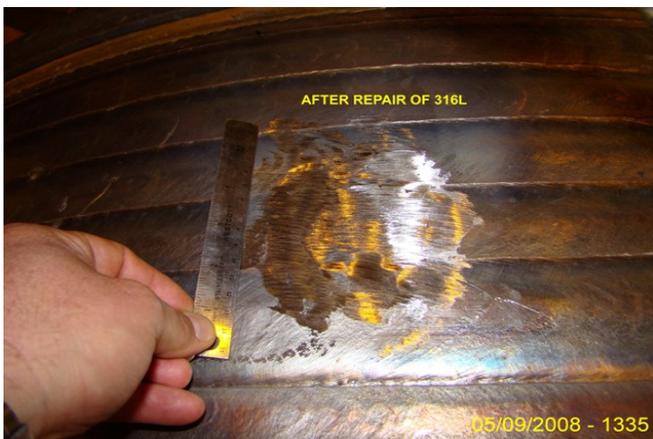
The photos below show the process being observed.
