DEPARTMENT OF TRANSPORTATION

Contract #: 04-0120F4Cty: SF/ALA Rte: 80 PM: 13.2/13.9File #: 69.28**WELDING INSPECTION REPORT****Resident Engineer:** Pursell, Gary**Address:** 333 Burma Road**City:** Oakland, CA 94607**Report No:** WIR-002432**Date Inspected:** 17-May-2008**Project Name:** SAS Superstructure**OSM Arrival Time:** 1800**Prime Contractor:** American Bridge/Fluor Enterprises, a JV**OSM Departure Time:** 730**Contractor:** Zhenhua Port Machinery Company, Ltd (ZPMC), Changxing Island **Location:** Shanghai, China**CWI Name:****CWI Present:**

Bridge No: 34-0006**Component:** OBG**Summary of Items Observed:**

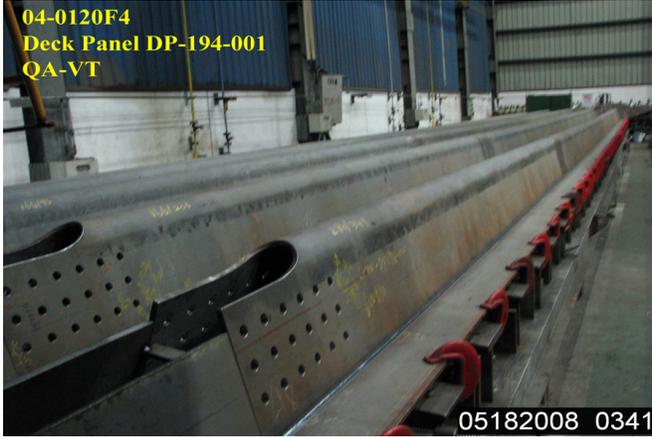
OBG Bay 1- Caltrans QA Inspector performed a Quality Assurance visual weld inspection on Orthotropic Box Girder (OBG) Deck Panel Assembly identified as DP194-001 partial joint penetration (PJP) welds 001 through 010, joining u-ribs to deck plate. QA Inspector observed various defects which include oversize weld, overlap, underfill, undercut and incomplete fusion. The length and the location of each of these areas were recorded on the Caltrans QA Visual Weld Inspection Report for the Orthotropic Box Girder (OBG) and Deck Panel for tracking and distributed to the appropriate personnel for review. The following digital picture illustrates deck panel DP194-001.
