DEPARTMENT OF TRANSPORTATION

Contract #: 04-0120F4Cty: SF/ALA Rte: 80 PM: 13.2/13.9File #: 69.28**WELDING INSPECTION REPORT****Resident Engineer:** Pursell, Gary**Address:** 333 Burma Road**City:** Oakland, CA 94607**Report No:** WIR-002437**Date Inspected:** 18-May-2008**Project Name:** SAS Superstructure**OSM Arrival Time:** 1930**Prime Contractor:** American Bridge/Fluor Enterprises, a JV**OSM Departure Time:** 700**Contractor:** Zhenhua Port Machinery Company, Ltd (ZPMC), Changxing Island **Location:** Shanghai China**CWI Name:** Chen Xi**CWI Present:** Yes No**Inspected CWI report:** Yes No N/A**Rod Oven in Use:** Yes No N/A**Electrode to specification:** Yes No N/A**Weld Procedures Followed:** Yes No N/A**Qualified Welders:** Yes No N/A**Verified Joint Fit-up:** Yes No N/A**Approved Drawings:** Yes No N/A**Approved WPS:** Yes No N/A**Delayed / Cancelled:** Yes No N/A**Bridge No:** 34-0006**Component:** Deck Panels**Summary of Items Observed:**

WELDING INSPECTION REPORT

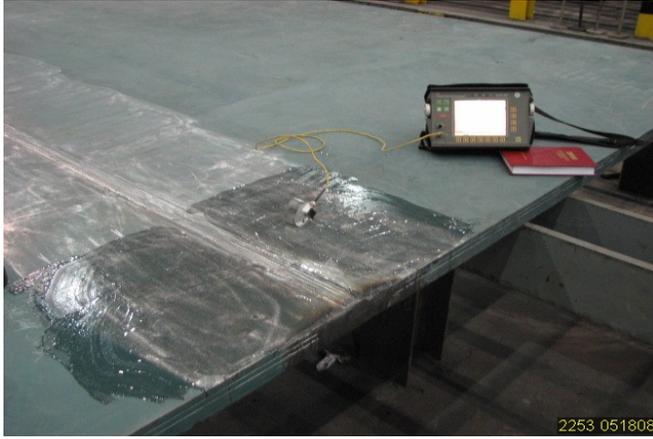
The Caltrans QA Inspector performed Ultrasonic Testing (UT) verification of the QC UT Inspected and accepted welds. This Inspector's visual and UT verification appears to be acceptable with AWS D1.5-02 section 6, table 6.3. Reference QA Ultrasonic Test Report TL-6027 dated 5/18/08 for specific test data.

Item	Description	WBS	Dwg No.	Status
1	Picture 1 at top left Typical UT examination of tower skin plate CLP weld splice, component SA179 D/E weld 19			
2	Picture 2 at top right Visual testing of Deck plate DP246-001 with a typical incomplete fusion indication on weld toe.

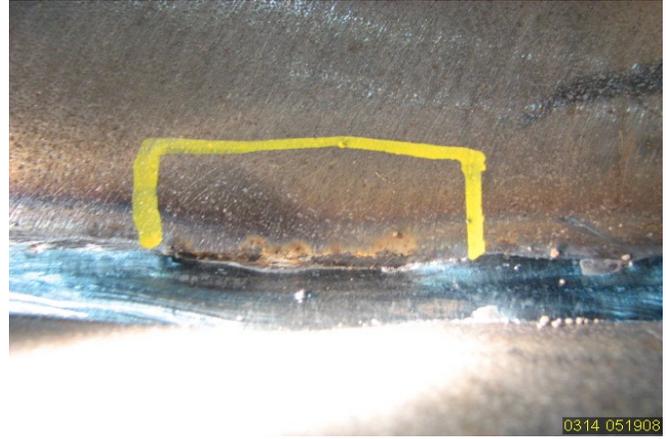
The Caltrans QA Inspector Mr. David Kelsey performed Visual Testing (VT) on DP246-001 & DP619-001 partial penetration welds 001 thru 010. This inspector marked and measured visual indication such as under-fill, overlap, oversized, undersized and incomplete fusion. Results were recorded on the deck panel inspection form and copies turned into the appropriate personnel and deck panel log book. No other observation took place during the shift by this inspector.
