**DEPARTMENT OF TRANSPORTATION**

Contract #: 04-0120F4Cty: SF/ALA Rte: 80 PM: 13.2/13.9File #: 69.28**WELDING INSPECTION REPORT****Resident Engineer:** Pursell, Gary**Address:** 333 Burma Road**City:** Oakland, CA 94607**Report No:** WIR-002482**Date Inspected:** 01-May-2008**Project Name:** SAS Superstructure**OSM Arrival Time:** 1500**Prime Contractor:** American Bridge/Fluor Enterprises, a JV**OSM Departure Time:** 100**Contractor:** Zhenhua Port Machinery Company, Ltd (ZPMC), Changxing Island **Location:** Shanghai China**CWI Name:** See observations below**CWI Present:** Yes No**Inspected CWI report:** Yes No N/A**Rod Oven in Use:** Yes No N/A**Electrode to specification:** Yes No N/A**Weld Procedures Followed:** Yes No N/A**Qualified Welders:** Yes No N/A**Verified Joint Fit-up:** Yes No N/A**Approved Drawings:** Yes No N/A**Approved WPS:** Yes No N/A**Delayed / Cancelled:** Yes No N/A**Bridge No:** 34-0006**Component:** Tower skin plates & OBG plate segments**Summary of Items Observed:**

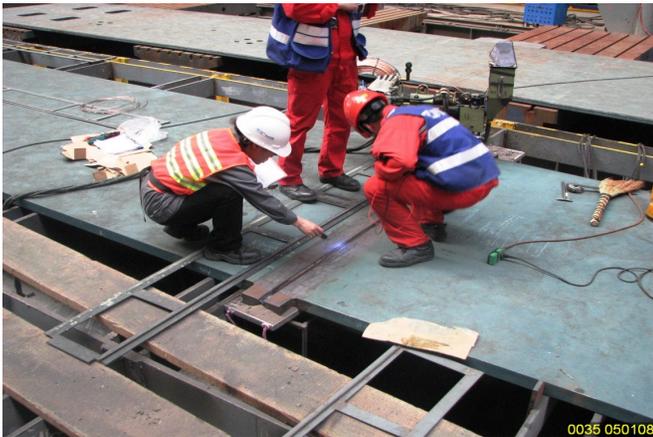
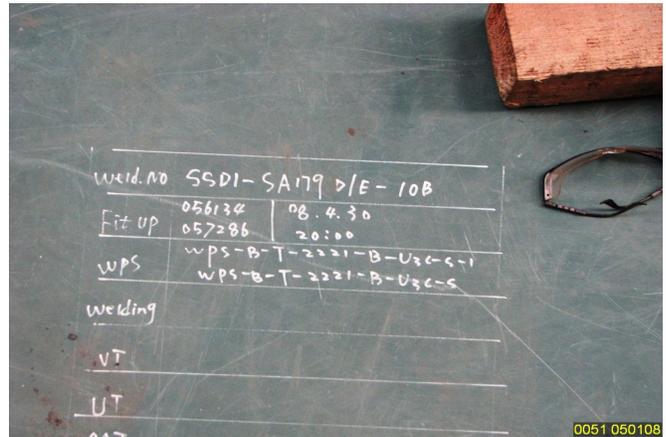
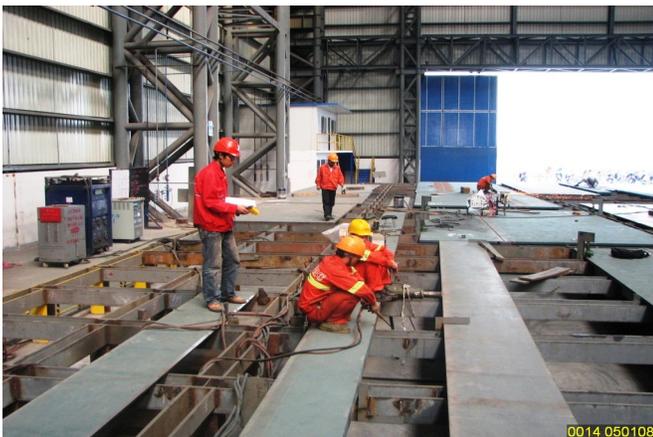
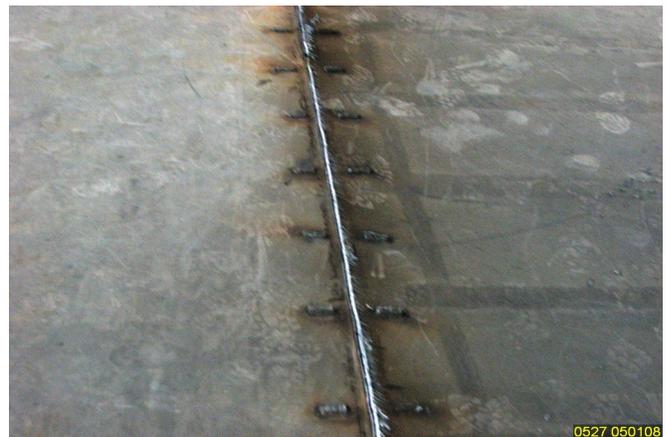
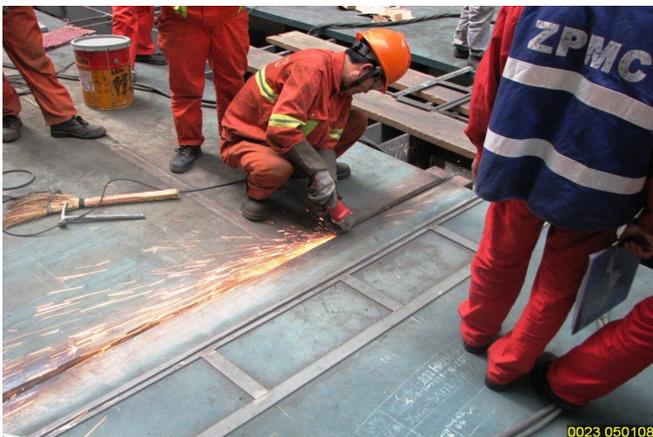
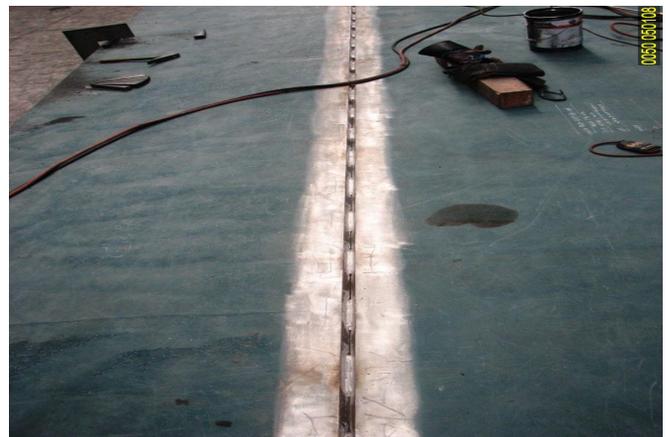
The in-process welding, fit-up & joint preparation, and thermal cutting observed by the Caltrans Inspector appears to comply with previously mentioned WPS, the approved drawings, the WQCP, Contract Special Provisions and AWS welding code D1.5. See attached pictures below.

Item	Description	WBS	Dwg No.	Status
1	SSDI SA173 A/K -16A CWI Au Jing Xiang & a ABF representative inspecting weld after a completed weld pass bead for acceptable cleaning and free of any visual indications.	WPS 2221-B-U3c-S		In-Work
2	SA179 D/E-10B Good legible component identification identifying workers I.D.# doing fit-up and welding.			In-work
3	Tower Skin Plate ZPMC monitoring thermal heat straightening of plate	Heat straightening Procedure HSRT (T) -1101		In-Work
4	Bottom Plate Splice Segment BP4A to BP5A Standard back-gouging of OBG bottom segment plate with the thermal carbon air arc process.			In-Work
5	SSDI Sa173 A/K-16A ZPMC personnel cleaning weld bead after a completed SAW weld pass	2221-B-U3c-S		In-Work
6	SA179 D/E-10B Fit-up and SMAW tack welding of weld joint. Tight and closed root gap, tack weld bead clean & ground to a smooth contour.			Fit-up

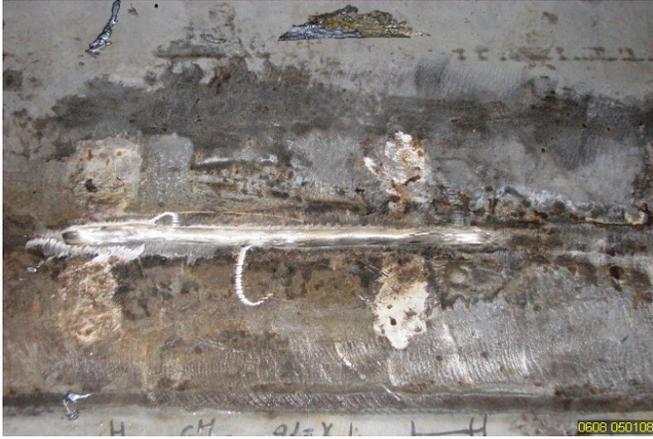
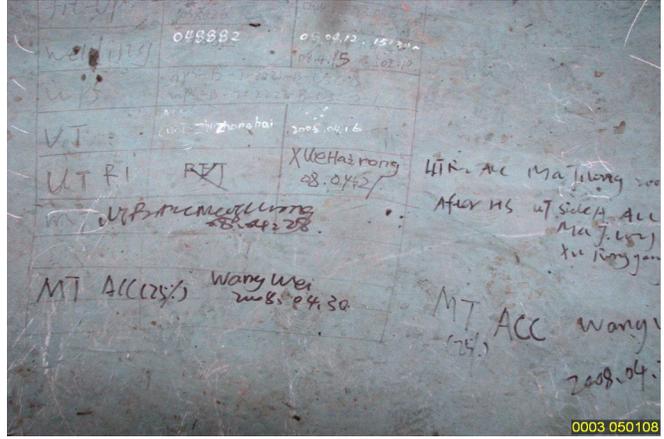
The Caltrans Inspector observed numerous plates with CJP weld splices both in the Tower Bay# 2 (Skin Plates) and the OBG assembly area (side & bottom segment splices) with numerous UT rejections and repairs and questioned an ABF representative about these concerns. ABF QC Representative Mr. Kevin Dye stated that it appears to be from inaccurate marking from the UT technicians and or interpretation of the markings (Y & X indication locations marked) by the worker excavating the marked indication from the ZPMC UT technicians. ABF has noted there is apparent communication lacking between the ZPMC UT technicians and the repair/welding crew when locating and excavating marked and reported indications. ABF suspects and is still investigating that many of the repeat repairs are not from new defects being added during the weld repair but original defects not being completely removed in the first place. It is questionable of the indication type description being located by the ZPMC UT Technicians because they just mark the location based on their indication rating without taking the time to evaluate a possible indication type for possible future corrective action by the welding crews. ABF representative also stated that the repair crew excavating the defects are not being careful that when they are in the suspected area of the indication to note the type and location of any indications thereby confirming the UT technicians findings for possible corrective action in the future. ABF stated that these concerns are to be brought to the attention of ZPMC QC personnel during their next scheduled tool box meetings. See the two pictures below.

Item	Description	WBS	Dwg No.	Status
1	Segment SP 015A-001 Example of one of several excavations on this component revealed by UT. This appears to be an R-1 for this particular segment. MT to be performed by ZPMC technicians after cleaning is completed on all excavations.			Repairing.
2	Tower skin plate Example of difficulty to determine inspection sequence/record by field writing directly on the component. R-1, R-2 completed or accepted? Difficult to determine by the information recorded here.			??
