DEPARTMENT OF TRANSPORTATION

Contract #: 04-0120F4Cty: SF/ALA Rte: 80 PM: 13.2/13.9File #: 69.28**WELDING INSPECTION REPORT****Resident Engineer:** Pursell, Gary**Address:** 333 Burma Road**City:** Oakland, CA 94607**Report No:** WIR-002499**Date Inspected:** 07-May-2008**Project Name:** SAS Superstructure**OSM Arrival Time:** 1530**Prime Contractor:** American Bridge/Fluor Enterprises, a JV**OSM Departure Time:** 2200**Contractor:** Zhenhua Port Machinery Company, Ltd (ZPMC), Changxing Island **Location:** Shanghai, China**CWI Name:** Xu Jun**CWI Present:** Yes No**Inspected CWI report:** Yes No N/A**Rod Oven in Use:** Yes No N/A**Electrode to specification:** Yes No N/A**Weld Procedures Followed:** Yes No N/A**Qualified Welders:** Yes No N/A**Verified Joint Fit-up:** Yes No N/A**Approved Drawings:** Yes No N/A**Approved WPS:** Yes No N/A**Delayed / Cancelled:** Yes No N/A**Bridge No:** 34-0006**Component:** OBG**Summary of Items Observed:**

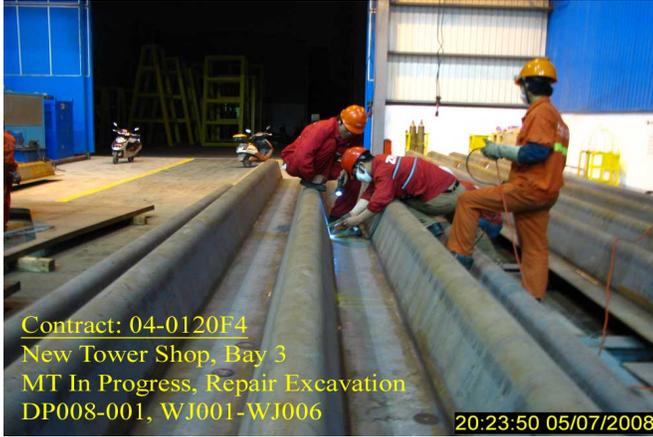
The QA Inspector performed visual inspection for DP008-001. This visual inspection was performed after initial inspections were performed and ZPMC performed excavations for repairs. The QA Inspector measured Y coordinates, excavation lengths, depths and recorded the information onto a Caltrans repair inspection report. The QA Inspector also observed ZPMC personnel perform initial magnetic particle testing (MT) for these excavations. The following picture below details the MT in process.
