DEPARTMENT OF TRANSPORTATION

Contract #: 04-0120F4Cty: SF/ALA Rte: 80 PM: 13.2/13.9File #: 69.28**WELDING INSPECTION REPORT****Resident Engineer:** Pursell, Gary**Address:** 333 Burma Road**City:** Oakland, CA 94607**Report No:** WIR-002503**Date Inspected:** 11-May-2008**Project Name:** SAS Superstructure**OSM Arrival Time:** 1400**Prime Contractor:** American Bridge/Fluor Enterprises, a JV**OSM Departure Time:** 2200**Contractor:** Zhenhua Port Machinery Company, Ltd (ZPMC), Changxing Island **Location:** Shanghai, China

WELDING INSPECTION REPORT

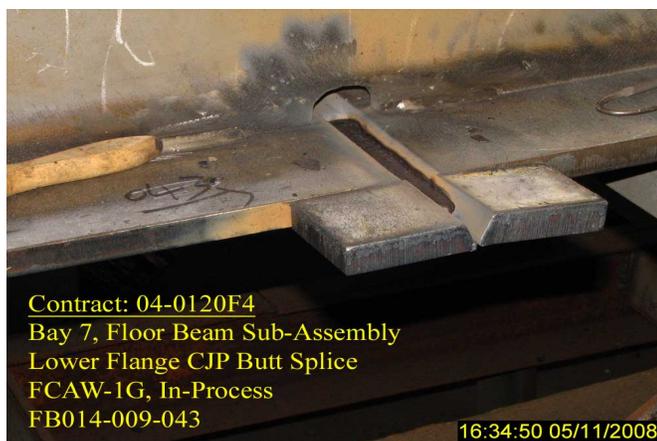
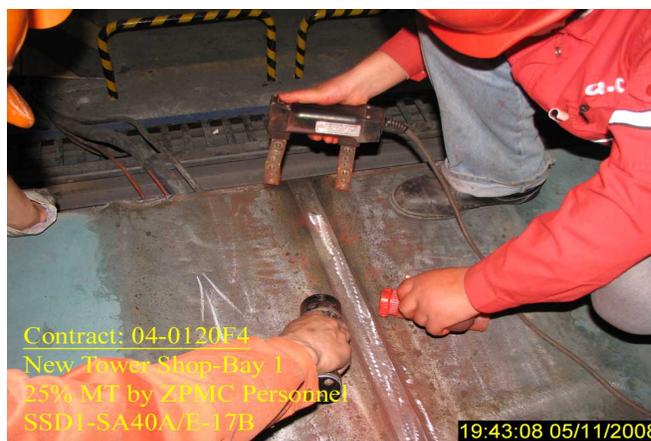
The following pictures below detail some of the work in progress on this date.
