**DEPARTMENT OF TRANSPORTATION**

Contract #: 04-0120F4Cty: SF/ALA Rte: 80 PM: 13.2/13.9File #: 69.28**WELDING INSPECTION REPORT****Resident Engineer:** Pursell, Gary**Address:** 333 Burma Road**City:** Oakland, CA 94607**Report No:** WIR-002504**Date Inspected:** 12-May-2008**Project Name:** SAS Superstructure**OSM Arrival Time:** 1400**Prime Contractor:** American Bridge/Fluor Enterprises, a JV**OSM Departure Time:** 2200**Contractor:** Zhenhua Port Machinery Company, Ltd (ZPMC), Changxing Island **Location:** Shanghai, China

<b>CWI Name:</b>	Shen Xue Jun			<b>CWI Present:</b>	<b>Yes</b>	<b>No</b>	
<b>Inspected CWI report:</b>	<b>Yes</b>	<b>No</b>	<b>N/A</b>	<b>Rod Oven in Use:</b>	<b>Yes</b>	<b>No</b>	<b>N/A</b>
<b>Electrode to specification:</b>	<b>Yes</b>	<b>No</b>	<b>N/A</b>	<b>Weld Procedures Followed:</b>	<b>Yes</b>	<b>No</b>	<b>N/A</b>
<b>Qualified Welders:</b>	<b>Yes</b>	<b>No</b>	<b>N/A</b>	<b>Verified Joint Fit-up:</b>	<b>Yes</b>	<b>No</b>	<b>N/A</b>
<b>Approved Drawings:</b>	<b>Yes</b>	<b>No</b>	<b>N/A</b>	<b>Approved WPS:</b>	<b>Yes</b>	<b>No</b>	<b>N/A</b>
				<b>Delayed / Cancelled:</b>	<b>Yes</b>	<b>No</b>	<b>N/A</b>
<b>Bridge No:</b>	34-0006			<b>Component:</b>	T

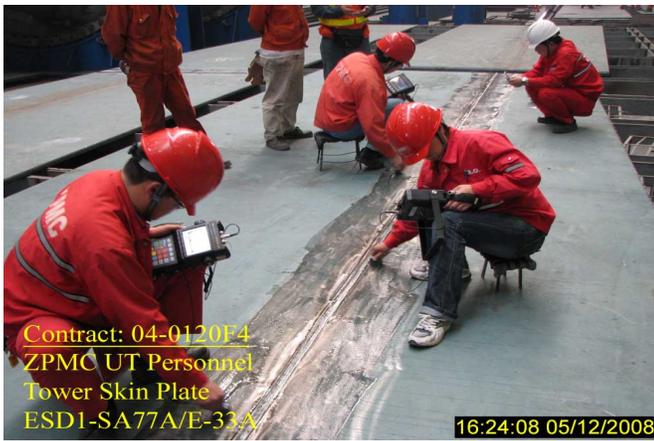
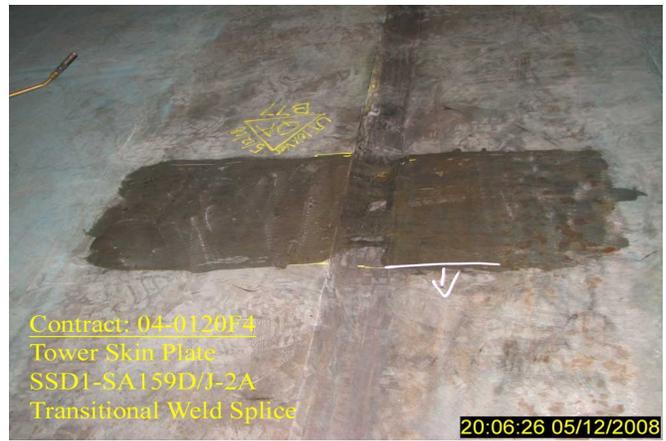
The QA Inspector performed full volumetric UT verification with a 70 degree shear wave transducer/plastic wedge combination to examine approximately 10% of the weld length that was ultrasonically scanned by ZPMC UT personnel for the CJP longitudinal butt weld splice connection on tower skin plate SSD1-SA179D/E-10A(10B).

The QA Inspector used 70 degree shear wave to examine the top quarter, middle half and bottom quarter of the 45mm plate. No relevant indications were reported upon completion of this inspection and TL-6027 UT report was generated on this date.

The QA Inspector also performed full volumetric UT verification with a 70 and a 45 degree shear wave transducer/plastic wedge combination to examine approximately 10% of the weld length that was ultrasonically scanned by ZPMC UT personnel for the CJP transitional butt weld splice connection on tower skin plate SSD1-SA159D/J-2A(2B). The QA Inspector also noted that ZPMC personnel accepted the weld joint after a previous UT rejection and weld repair. The QA Inspector used a 45 degree shear wave to examine the top quarter and a 70 degree shear wave to examine both the middle half and bottom quarter of the weld for the 90mm thick plate. No relevant indications were reported upon completion of this inspection and a TL-6027 UT report was generated for this item on this date.

The following pictures below detail the transitional butt splice weld and one of the longitudinal butt splices that were examined on this date.
