**DEPARTMENT OF TRANSPORTATION**

Contract #: 04-0120F4Cty: SF/ALA Rte: 80 PM: 13.2/13.9File #: 69.28**WELDING INSPECTION REPORT****Resident Engineer:** Pursell, Gary**Address:** 333 Burma Road**City:** Oakland, CA 94607**Report No:** WIR-002505**Date Inspected:** 14-May-2008**Project Name:** SAS Superstructure**OSM Arrival Time:** 1430**Prime Contractor:** American Bridge/Fluor Enterprises, a JV**OSM Departure Time:** 2200**Contractor:** Zhenhua Port Machinery Company, Ltd (ZPMC), Changxing Island **Location:** Shanghai, China**CWI Name:** Wang Lu (Testino)**CWI Present:** Yes No**Inspected CWI report:** Yes No N/A**Rod Oven in Use:** Yes No N/A**Electrode to specification:** Yes No N/A**Weld Procedures Followed:** Yes No N/A**Qualified Welders:** Yes No N/A**Verified Joint Fit-up:** Yes No N/A**Approved Drawings:** Yes No N/A**Approved WPS:** Yes No N/A**Delayed / Cancelled:** Yes No N/A**Bridge No:** 34-0006**Component:** OBG Deck Panels**Summary of Items Observed:**

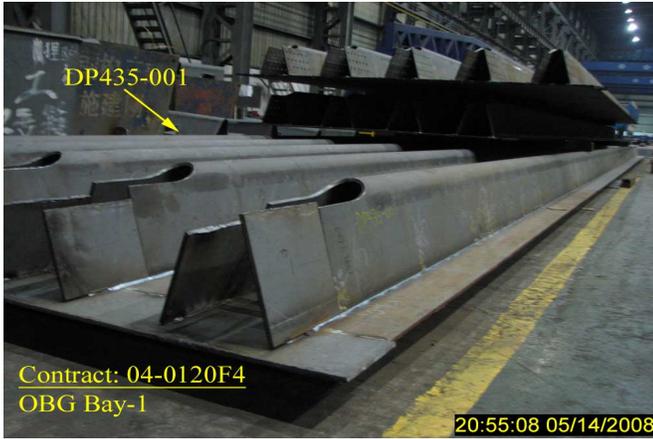
The QA Inspector began initial visual testing (VT) for deck panel, DP453-001 on weld joint 001. After marking the defective areas of the weld length, the QA Inspector recorded the Y locations, length and defect type onto a Caltrans VT report. At approximately 1830hrs, ZPMC re-located this deck panel from the gantry table to the shop floor towards the front of the bay and stacked two additional panels on top while the visual inspection was still in process. When the QA Inspector returned from lunch break, it was noted that weld joint 002 through 009 were now inaccessible. The QA Inspector informed ZPMC QC personnel Wang Lu (Testino) about the priority of the VT for this deck panel and stated that the two panels stacked on top need to be removed to continue inspection. Mr. Wang Lu informed the QA Inspector that he would ask the ZPMC shop personnel to remove those panels. At approximately 1940hrs, Mr. Wang Lu informed the QA Inspector that the ZPMC shop personnel would relocate those panels between 2020hrs and 2030hrs. As of 2130hrs the QA Inspector noted that ZPMC failed to remove the additional deck panels off the stack. The QA Inspector could not resume VT for the remainder of swing shift. This information was relayed to swing shift QA Task Leader Albert Carreon.
