DEPARTMENT OF TRANSPORTATION

Contract #: 04-0120F4Cty: SF/ALA Rte: 80 PM: 13.2/13.9File #: 69.28**WELDING INSPECTION REPORT****Resident Engineer:** Pursell, Gary**Address:** 333 Burma Road**City:** Oakland, CA 94607**Report No:** WIR-002509**Date Inspected:** 17-May-2008**Project Name:** SAS Superstructure**OSM Arrival Time:** 1500**Prime Contractor:** American Bridge/Fluor Enterprises, a JV**OSM Departure Time:** 2200**Contractor:** Zhenhua Port Machinery Company, Ltd (ZPMC), Changxing Island **Location:** Shanghai, China

OBG-Bay 1

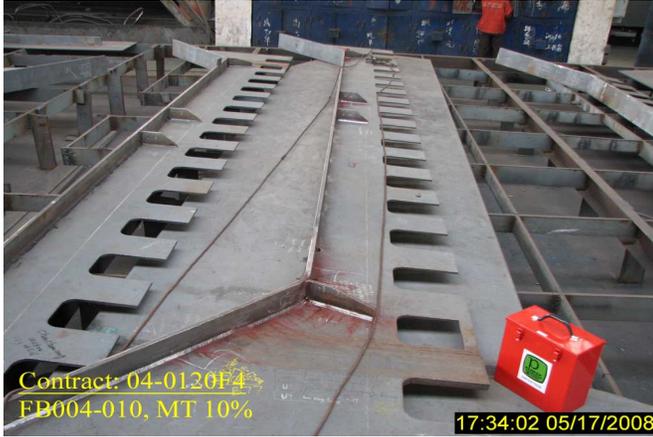
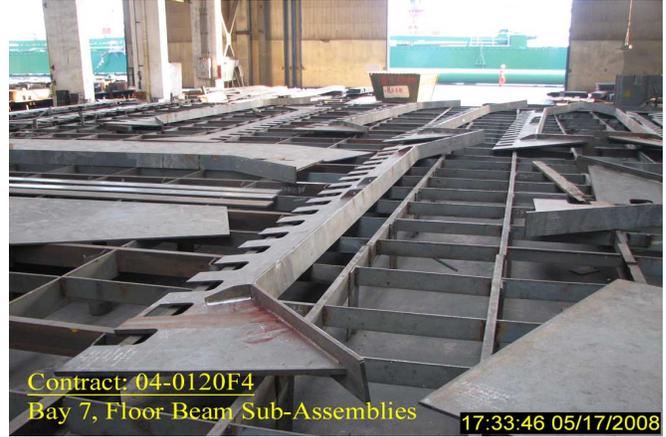
The QA Inspector performed magnetic particle testing (MT) for several floor beam sub-assemblies that were said to have previously received 25% MT by ZPMC personnel. The QA Inspector performed MT for approximately 10% of what was previously MT inspected by ZPMC. The following sub-assemblies were inspected; FB005-014, FB005-012, FB004-10 and FB013-012. Approximately fourteen (14ea) weld joints on each assembly were randomly verified by MT. No apparent relevant indications were observed at the time of testing and a TL-6028 MT report was generated on this date.

The following digital images below detail the sub-assemblies in bay 7 where the MT was performed.
