**DEPARTMENT OF TRANSPORTATION**

Contract #: 04-0120F4Cty: SF/ALA Rte: 80 PM: 13.2/13.9File #: 69.28**WELDING INSPECTION REPORT****Resident Engineer:** Pursell, Gary**Address:** 333 Burma Road**City:** Oakland, CA 94607**Report No:** WIR-002520**Date Inspected:** 15-May-2008**Project Name:** SAS Superstructure**OSM Arrival Time:** 1400**Prime Contractor:** American Bridge/Fluor Enterprises, a JV**OSM Departure Time:** 2330**Contractor:** Zhenhua Port Machinery Company, Ltd (ZPMC), Changxing Island **Location:** Shanghai, China

# WELDING INSPECTION REPORT

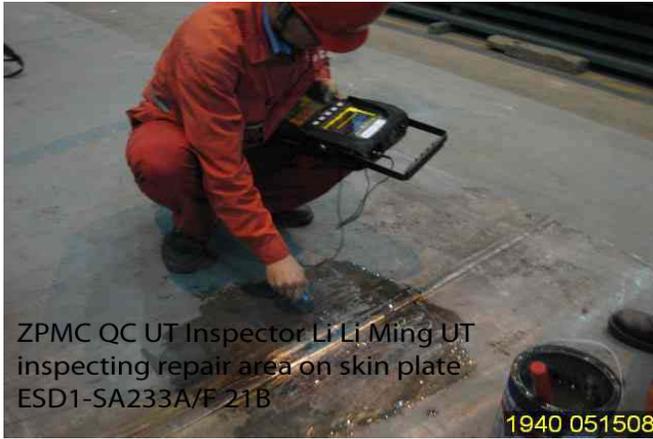
Tower Bay 2: QA Inspector observed ZPMC QC UT inspection after repair on 45mm thick skin plate ESD1-233A/F 21B side B. QA Inspector noted that QC UT inspection and methods appear to meet the requirements of AWS D1.5, special provisions and contract documents. QC UT Inspectors Li Li Ming and Xue Hai Vong accepted weld repair and noted the inspection as acceptable on the skin plate.

ZPMC QC UT Inspector Li Li Ming UT inspecting repair area on skin plate ESD1-SA233A/F 21B

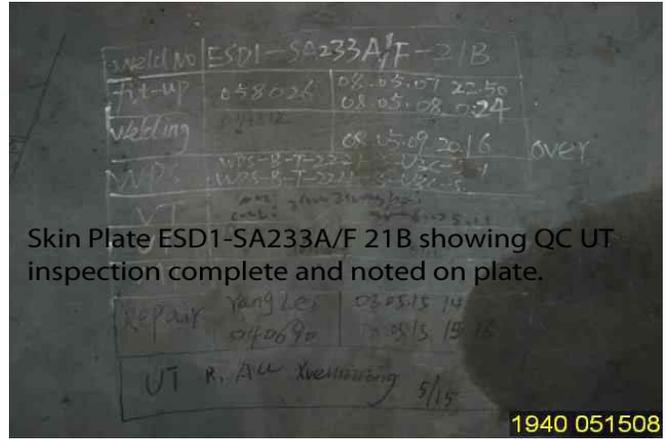
Skin Plate ESD1-SA233A/F 21B showing QC UT inspection complete and noted on plate.
