DEPARTMENT OF TRANSPORTATION

Quality Assurance and Source Inspection

Contract #: 04-0120F4Cty: SF/ALA Rte: 80 PM: 13.2/13.9File #: 69.28**WELDING INSPECTION REPORT****Resident Engineer:** Pursell, Gary**Address:** 333 Burma Road**City:** Oakland, CA 94607**Report No:** WIR-002592**Date Inspected:** 19-Apr-2008**Project Name:** SAS Superstructure**OSM Arrival Time:** 630**Prime Contractor:** American Bridge/Fluor Enterprises, a JV**OSM Departure Time:** 1930**Contractor:** Zhenhua Port Machinery Company, Ltd (ZPMC), Changxing Island **Location:** Shanghai, China**CWI Name:** See below**CWI Present:** Yes No**Inspected CWI report:** Yes No N/A**Rod Oven in Use:** Yes No N/A**Electrode to specification:** Yes No N/A**Weld Procedures Followed:** Yes No N/A**Qualified Welders:** Yes No N/A**Verified Joint Fit-up:** Yes No N/A**Approved Drawings:** Yes No N/A**Approved WPS:** Yes No N/A**Delayed / Cancelled:** Yes No N/A**Bridge No:** 34-0006**Component:** OBG/Tower**Summary of Items Observed:**

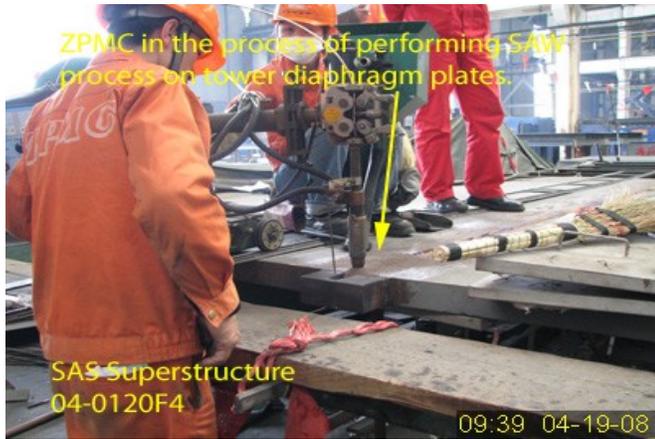
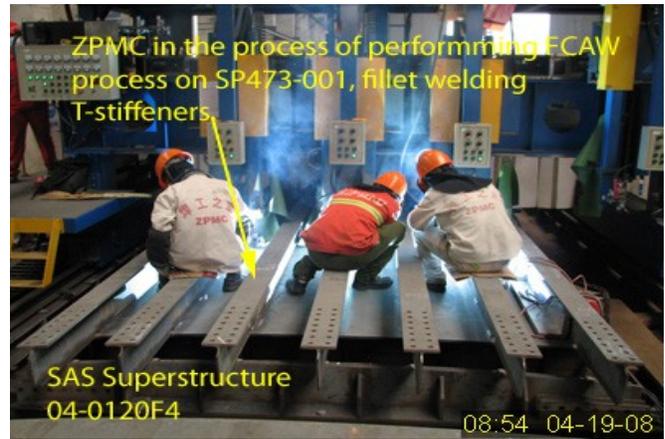
The following digital photograph below illustrates observation of the activities being performed.
