DEPARTMENT OF TRANSPORTATION

Quality Assurance and Source Inspection

Contract #: 04-0120F4Cty: SF/ALA Rte: 80 PM: 13.2/13.9File #: 69.28**WELDING INSPECTION REPORT****Resident Engineer:** Pursell, Gary**Address:** 333 Burma Road**City:** Oakland, CA 94607**Report No:** WIR-002620**Date Inspected:** 23-May-2008**Project Name:** SAS Superstructure**OSM Arrival Time:** 1500**Prime Contractor:** American Bridge/Fluor Enterprises, a JV**OSM Departure Time:** 2230**Contractor:** Zhenhua Port Machinery Company, Ltd (ZPMC), Changxing Island **Location:** Shanghai, China**CWI Name:** Fu Yuhong**CWI Present:** Yes No**Inspected CWI report:** Yes No N/A**Rod Oven in Use:** Yes No N/A**Electrode to specification:** Yes No N/A**Weld Procedures Followed:** Yes No N/A**Qualified Welders:** Yes No N/A**Verified Joint Fit-up:** Yes No N/A**Approved Drawings:** Yes No N/A**Approved WPS:** Yes No N/A**Delayed / Cancelled:** Yes No N/A**Bridge No:** 34-0006**Component:** OBG Deck Panels**Summary of Items Observed:**

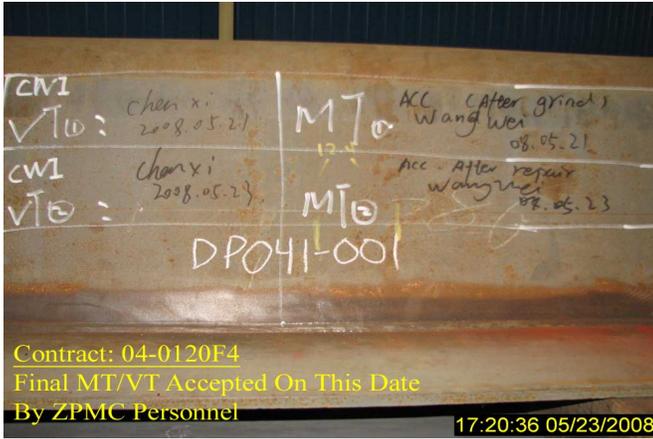
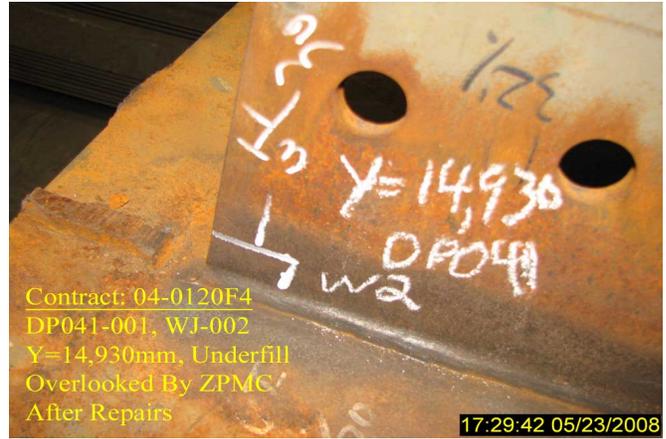
Later in the shift, the QA Inspector began final VT on DP041-001 and observed 130mm of overlap after repairs were attempted by ZPMC on weld joint 4. The QA Inspector measured the Y location beginning at 13,478mm. Also on DP041-001, weld joint 2, beginning at Y location 14,930mm, the QA Inspector observed approximately 30mm of under fill that was not repaired and appeared to be overlooked by ZPMC during repairs. These two areas were brought to the attention of ZPMC QC personnel Fu Yuhong and Caltrans QA Inspectors Steve Hall and Roscoe Dixon. Later in the shift, ZPMC personnel completed welding and grinding for the area where the under fill was observed and completed grinding in the area where the overlap was observed. Once these two areas were addressed, the remaining final VT and MT inspections were completed on second shift by QA Inspector Steve Hall.
