DEPARTMENT OF TRANSPORTATION

Contract #: 04-0120F4Cty: SF/ALA Rte: 80 PM: 13.2/13.9File #: 69.28**WELDING INSPECTION REPORT****Resident Engineer:** Pursell, Gary**Address:** 333 Burma Road**City:** Oakland, CA 94607**Report No:** WIR-002699**Date Inspected:** 16-May-2008**Project Name:** SAS Superstructure**OSM Arrival Time:** 700**Prime Contractor:** American Bridge/Fluor Enterprises, a JV**OSM Departure Time:** 1700**Contractor:** Zhenhua Port Machinery Company, Ltd (ZPMC), Changxing Island **Location:** Shanghai, China**CWI Name:** Chen chin Meng**CWI Present:** Yes No**Inspected CWI report:** Yes No N/A**Rod Oven in Use:** Yes No N/A**Electrode to specification:** Yes No N/A**Weld Procedures Followed:** Yes No N/A**Qualified Welders:** Yes No N/A**Verified Joint Fit-up:** Yes No N/A**Approved Drawings:** Yes No N/A**Approved WPS:** Yes No N/A**Delayed / Cancelled:** Yes No N/A**Bridge No:** 34-0006**Component:** Side Plates, Bottom Plates, Floor Beams, Dec**Summary of Items Observed:**

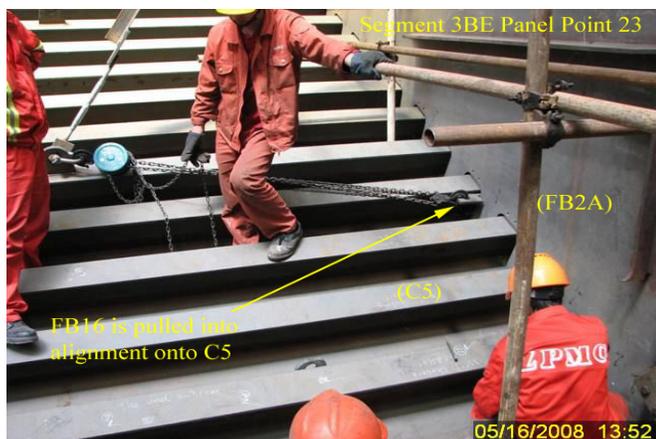
Segment 3BE(SEG16A) Panel Point 23- Caltrans QA observed ZPMC personnel performing bevel preparation of the CJP weld joining FL2-2 South to FL1-1 South. The joint is offset laterally by 20mm but has not been tacked welded. ZPMC QC is aware of the misalignment and will correct the issue prior to welding the joint. Caltrans QA also observed ZPMC performing work to correct the misalignment of FL1-1(FB16) South. ZPMC personnel are using chain falls to pull the bottom of the member into the correct alignment on Segment C5. See attached Photo.
