**DEPARTMENT OF TRANSPORTATION**

Contract #: 04-0120F4Cty: SF/ALA Rte: 80 PM: 13.2/13.9File #: 69.28**WELDING INSPECTION REPORT****Resident Engineer:** Pursell, Gary**Address:** 333 Burma Road**City:** Oakland, CA 94607**Report No:** WIR-002758**Date Inspected:** 25-May-2008**Project Name:** SAS Superstructure**OSM Arrival Time:** 2300**Prime Contractor:** American Bridge/Fluor Enterprises, a JV**OSM Departure Time:** 800**Contractor:** Zhenhua Port Machinery Company, Ltd (ZPMC), Changxing Island **Location:** Changxing Island**CWI Name:** Sun Wei**CWI Present:** Yes No**Inspected CWI report:** Yes No N/A**Rod Oven in Use:** Yes No N/A**Electrode to specification:** Yes No N/A**Weld Procedures Followed:** Yes No N/A**Qualified Welders:** Yes No N/A**Verified Joint Fit-up:** Yes No N/A**Approved Drawings:** Yes No N/A**Approved WPS:** Yes No N/A**Delayed / Cancelled:** Yes No N/A**Bridge No:** 34-0006**Component:** OBG**Summary of Items Observed:**

# WELDING INSPECTION REPORT

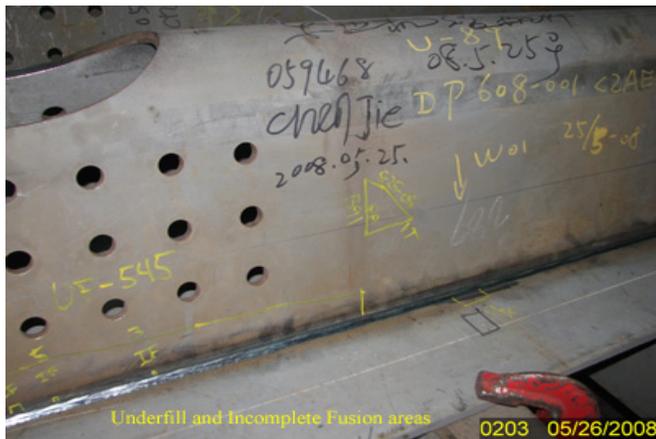
The Caltrans QA Inspector performed visual inspection of OBG 11.355 meter deck panel DP608-001 (welds 001 through 006) U-rib Partial Joint Penetration (PJP) welds. Visual testing of welding was performed in accordance with contract documents. The following discontinuities were found during inspection on the Submerged Arc Welding (SAW) cover pass, incomplete fusion, overlap, undercut, underfill and oversize welds. Welding discontinuities were marked on deck panel with a permanent marker, length and Y location recorded. Visual Inspection results were distributed to the appropriate personnel for review. A summary of discontinuities on inspected U-rib PJP welds are listed below. Please see the attached photo of Underfill and Incomplete Fusion

identified during inspection.

DP608-001

DP608-001-001, Incomplete Fusion 7 areas, Underfill 6 areas, and Overlap 2 areas

DP608-001-002, Underfill 7 areas

DP608-001-003, Incomplete Fusion 2 areas, Underfill 9 areas, and Undercut 2 areas

DP608-001-004, Incomplete Fusion 4 area, Underfill 8 areas, and Overlap 1 area

DP608-001-005, Incomplete Fusion 1 area, Underfill 6 areas, and Undercut 1 area

DP608-001-006, Incomplete Fusion 7 areas, and Underfill 8 areas, and Oversize 1 area
