**DEPARTMENT OF TRANSPORTATION**

Contract #: 04-0120F4Cty: SF/ALA Rte: 80 PM: 13.2/13.9File #: 69.28**WELDING INSPECTION REPORT****Resident Engineer:** Pursell, Gary**Address:** 333 Burma Road**City:** Oakland, CA 94607**Report No:** WIR-002789**Date Inspected:** 21-Nov-2007**Project Name:** SAS Superstructure**OSM Arrival Time:** 630**Prime Contractor:** American Bridge/Fluor Enterprises, a JV**OSM Departure Time:** 1530**Contractor:** Zhenhua Port Machinery Company, Ltd (ZPMC), Changxing Island **Location:** Shanghai, China**CWI Name:** Sun Wei**CWI Present:** Yes No**Inspected CWI report:** Yes No N/A**Rod Oven in Use:** Yes No N/A**Electrode to specification:** Yes No N/A**Weld Procedures Followed:** Yes No N/A**Qualified Welders:** Yes No N/A**Verified Joint Fit-up:** Yes No N/A**Approved Drawings:** Yes No N/A**Approved WPS:** Yes No N/A**Delayed / Cancelled:** Yes No N/A**Bridge No:** 34-0006**Component:** Tower Mock-up and OBG**Summary of Items Observed:**

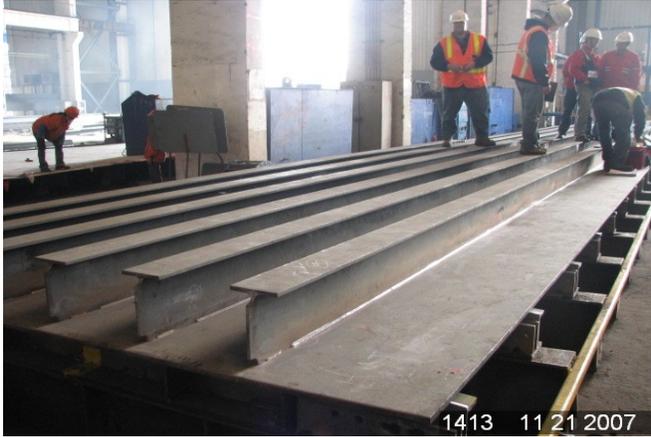
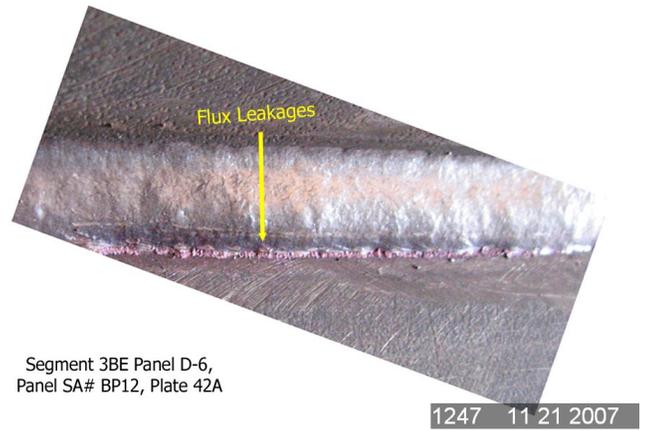
Segment 3BE Panel D-6,  
Panel SA# BP12, Plate 42A

2	Visual inspection to the PL42A The QA inspector assisted to Larry Viars to perform preliminary visual weld inspection to the fillet welds on three Tee stiffeners at the junctions of the bottom plate PL 42A and the Tee stiffeners joint # BP-012-01-013 thru 018. After ZPMC repair areas marked by the QA inspector welds appeared to be in compliance with contract documents. The photographs below shows the bottom plate PL42A and the magnetic particle indications detected by Caltrans QA inspector Larry Viars.
