**DEPARTMENT OF TRANSPORTATION**

Contract #: 04-0120F4Cty: SF/ALA Rte: 80 PM: 13.2/13.9File #: 69.28**WELDING INSPECTION REPORT****Resident Engineer:** Pursell, Gary**Address:** 333 Burma Road**City:** Oakland, CA 94607**Report No:** WIR-002799**Date Inspected:** 03-Jun-2008**Project Name:** SAS Superstructure**OSM Arrival Time:** 630**Prime Contractor:** American Bridge/Fluor Enterprises, a JV**OSM Departure Time:** 1530**Contractor:** Zhenhua Port Machinery Company, Ltd (ZPMC), Changxing Island **Location:** Shanghai, China**CWI Name:** Lvliqing and Shazhi**CWI Present:** Yes No**Inspected CWI report:** Yes No N/A**Rod Oven in Use:** Yes No N/A**Electrode to specification:** Yes No N/A**Weld Procedures Followed:** Yes No N/A**Qualified Welders:** Yes No N/A**Verified Joint Fit-up:** Yes No N/A**Approved Drawings:** Yes No N/A**Approved WPS:** Yes No N/A**Delayed / Cancelled:** Yes No N/A**Bridge No:** 34-0006**Component:** OBG and SAS Tower Fabrication**Summary of Items Observed:**

On this date, Caltrans Office of Structural Material (OSM) Quality Assurance (QA) Inspector Joselito Lizardo was present as requested to perform observations on the fabrication of Orthotropic Box Gir

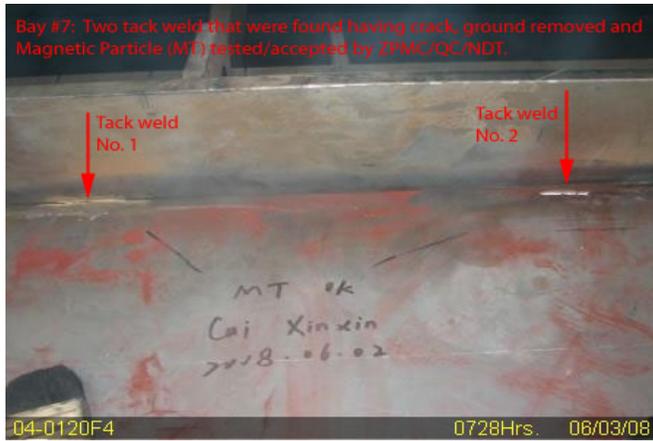
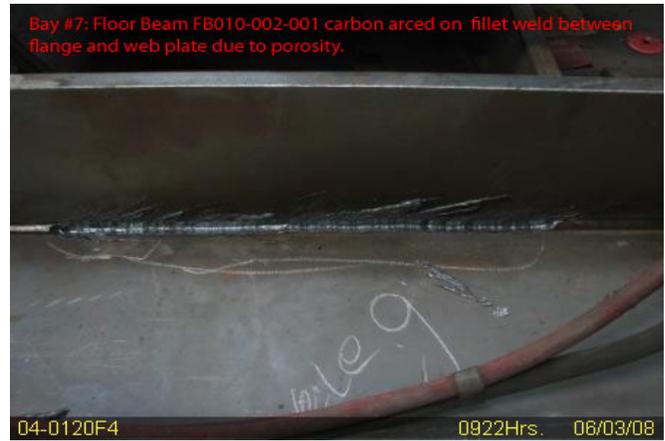
This QA Inspector was asked by Task Leader to follow up on tack welds that were reportedly have cracked on floor beam FB010-002-001(NS). Upon arrival, this QA observed the two tack welds that cracked have already been ground removed and tested/accepted with Magnetic Particle (MT) by ZPMC/QC. This QA went back to the office to get the electromagnetic yoke to MT verify the cracked tack weld removal but as soon as this QA arrived at the scene, the area where the cracked tack weld located was already FCAW fillet welded.
