**DEPARTMENT OF TRANSPORTATION**

Contract #: 04-0120F4Cty: SF/ALA Rte: 80 PM: 13.2/13.9File #: 69.28**WELDING INSPECTION REPORT****Resident Engineer:** Pursell, Gary**Address:** 333 Burma Road**City:** Oakland, CA 94607**Report No:** WIR-002841**Date Inspected:** 28-May-2008**Project Name:** SAS Superstructure**OSM Arrival Time:** 630**Prime Contractor:** American Bridge/Fluor Enterprises, a JV**OSM Departure Time:** 1530**Contractor:** Zhenhua Port Machinery Company, Ltd (ZPMC), Changxing Island **Location:** Shanghai, China**CWI Name:** Fu Yu Hong**CWI Present:** Yes No**Inspected CWI report:** Yes No N/A**Rod Oven in Use:** Yes No N/A**Electrode to specification:** Yes No N/A**Weld Procedures Followed:** Yes No N/A**Qualified Welders:** Yes No N/A**Verified Joint Fit-up:** Yes No N/A**Approved Drawings:** Yes No N/A**Approved WPS:** Yes No N/A**Delayed / Cancelled:** Yes No N/A**Bridge No:** 34-0006**Component:** Tower**Summary of Items Observed:**

# WELDING INSPECTION REPORT

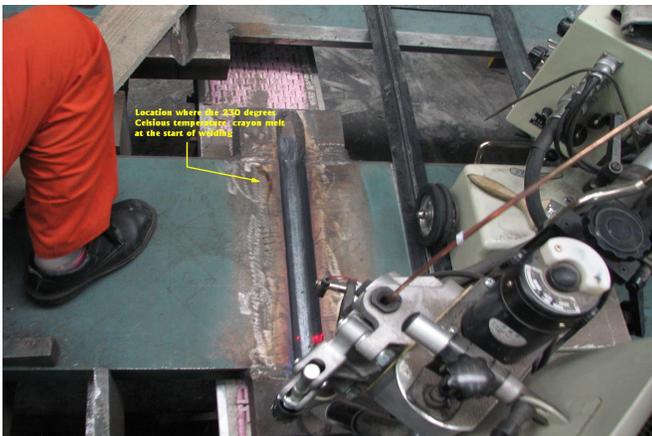
## Magnetic particle inspection at the end of the weld joint a

The QA inspector performed (MT) at the end of the joint after removing and grinding the run on tabs at the junction of the ESD1-SA-233-A/F-21A East lift 1. The QA inspector found a relevant indication at the end of the joint. The QA inspector had conversation with ZPMC representative Xu Jun . The QA inspector brought it to the attention of ZPMC that it appeared that ZPMC has overlooked an indication that is approximately 8 mm long.
