DEPARTMENT OF TRANSPORTATION

Quality Assurance and Source Inspection

Contract #: 04-0120F4Cty: SF/ALA Rte: 80 PM: 13.2/13.9File #: 69.28**WELDING INSPECTION REPORT****Resident Engineer:** Pursell, Gary**Address:** 333 Burma Road**City:** Oakland, CA 94607**Report No:** WIR-002850**Date Inspected:** 06-Jun-2008**Project Name:** SAS Superstructure**OSM Arrival Time:** 630**Prime Contractor:** American Bridge/Fluor Enterprises, a JV**OSM Departure Time:** 1530**Contractor:** Zhenhua Port Machinery Company, Ltd (ZPMC), Changxing Island **Location:** Shanghai, China**CWI Name:** C. M. Shen**CWI Present:** Yes No**Inspected CWI report:** Yes No N/A**Rod Oven in Use:** Yes No N/A**Electrode to specification:** Yes No N/A**Weld Procedures Followed:** Yes No N/A**Qualified Welders:** Yes No N/A**Verified Joint Fit-up:** Yes No N/A**Approved Drawings:** Yes No N/A**Approved WPS:** Yes No N/A**Delayed / Cancelled:** Yes No N/A**Bridge No:** 34-0006**Component:** OBG**Summary of Items Observed:**

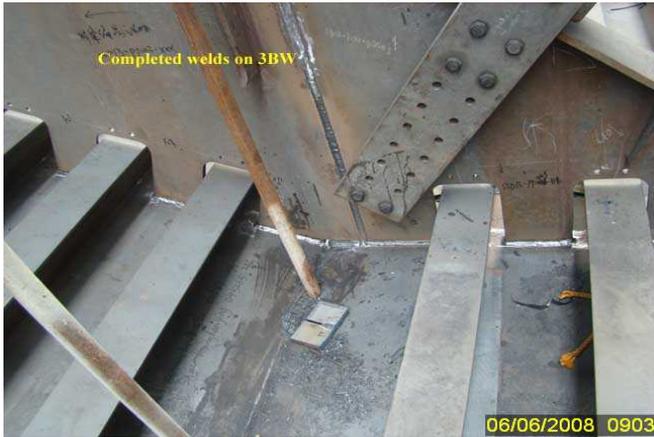
OBG Assembly Segment 3BW- The Caltrans QA Inspector observed that ZPMC has completed the welding of the FL2 and FL1 Floor beam segments.
