Contract #: 04-0120F4Cty: SF/ALA Rte: 80 PM: 13.2/13.9File #: 69.28**WELDING INSPECTION REPORT****Resident Engineer:** Pursell, Gary**Address:** 333 Burma Road**City:** Oakland, CA 94607**Report No:** WIR-002852**Date Inspected:** 05-Jun-2008**Project Name:** SAS Superstructure**OSM Arrival Time:** 700**Prime Contractor:** American Bridge/Fluor Enterprises, a JV**OSM Departure Time:** 1700**Contractor:** Zhenhua Port Machinery Company, Ltd (ZPMC), Changxing Island **Location:** Shanghai, China**CWI Name:** Sun Wei**CWI Present:** Yes No**Inspected CWI report:** Yes No N/A**Rod Oven in Use:** Yes No N/A**Electrode to specification:** Yes No N/A**Weld Procedures Followed:** Yes No N/A**Qualified Welders:** Yes No N/A**Verified Joint Fit-up:** Yes No N/A**Approved Drawings:** Yes No N/A**Approved WPS:** Yes No N/A**Delayed / Cancelled:** Yes No N/A**Bridge No:** 34-0006**Component:** OBG and Tower Mock-ups**Summary of Items Observed:**

77M Tower Partial Mock-Ups

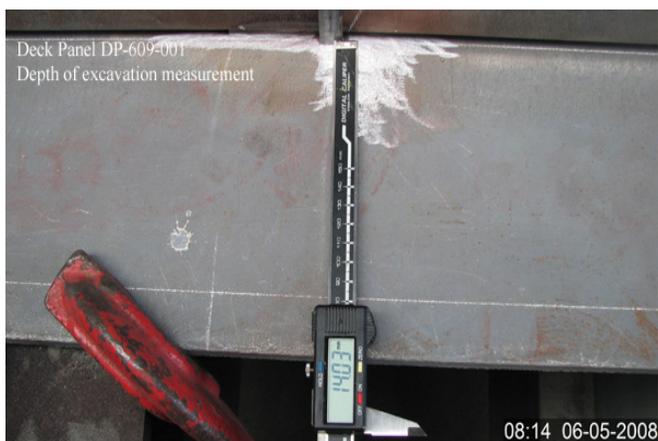
DP-609-001

The Quality Assurance Inspector performed a survey measuring the depth of excavation of 10 cracked tack weld repairs. The excavations ranged from 8 millimeters to 14 millimeters. Below is a digital photograph illustrating the measurement of the excavation utilizing digital calipers. In addition the Quality Assurance Inspector observed several areas where the base metal of the deck panel was ground approximately 3 millimeters. Caltrans Inspector

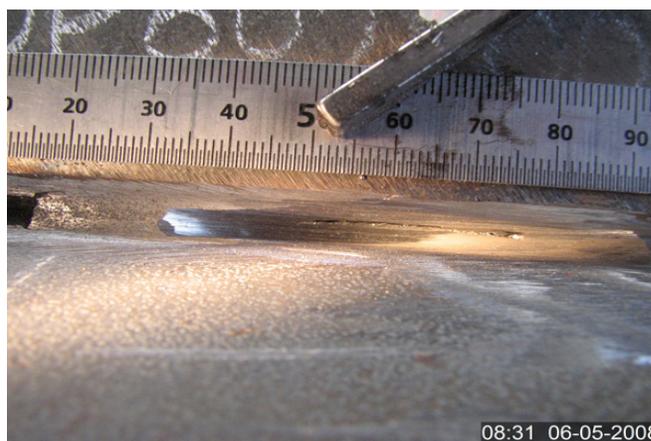
Alfredo Acuna performed Ultrasonic Testing to the base metal due to the inaccessibility of measuring the base metal manually. Mr. Acuna tested one area and stated the 15 millimeter panel was now 11.58 millimeters in thickness. Below is a digital photograph of an excavation in effort to illustrate the amount of grinding into the base metal. Later in the shift, ZPMC relayed that all repairs to the cracked tack welds previously identified within Deck Panel DP-609-001 have been made and retested by the magnetic particle method. The previous day ABF representative Warren Buehler identified approximately 30 welds containing crack like indications that ZPMC relayed were already repaired and tested. The Quality Assurance Inspector performed magnetic particle testing to the 30 welds identified and recorded 5 that contained crack like indications. ZPMC was present during the testing and immediately marked the areas for repair.
