DEPARTMENT OF TRANSPORTATION

Contract #: 04-0120F4Cty: SF/ALA Rte: 80 PM: 13.2/13.9File #: 69.28**WELDING INSPECTION REPORT****Resident Engineer:** Pursell, Gary**Address:** 333 Burma Road**City:** Oakland, CA 94607**Report No:** WIR-002875**Date Inspected:** 10-Jun-2008**Project Name:** SAS Superstructure**OSM Arrival Time:** 630**Prime Contractor:** American Bridge/Fluor Enterprises, a JV**OSM Departure Time:** 1530**Contractor:** Zhenhua Port Machinery Company, Ltd (ZPMC), Changxing Island **Location:** Shanghai, China**CWI Name:** Lvliqing and Hu Wei Qing**CWI Present:** Yes No**Inspected CWI report:** Yes No N/A**Rod Oven in Use:** Yes No N/A**Electrode to specification:** Yes No N/A**Weld Procedures Followed:** Yes No N/A**Qualified Welders:** Yes No N/A**Verified Joint Fit-up:** Yes No N/A**Approved Drawings:** Yes No N/A**Approved WPS:** Yes No N/A**Delayed / Cancelled:** Yes No N/A**Bridge No:** 34-0006**Component:** OBG and SAS Tower Fabrication**Summary of Items Observed:**

WELDING INSPECTION REPORT

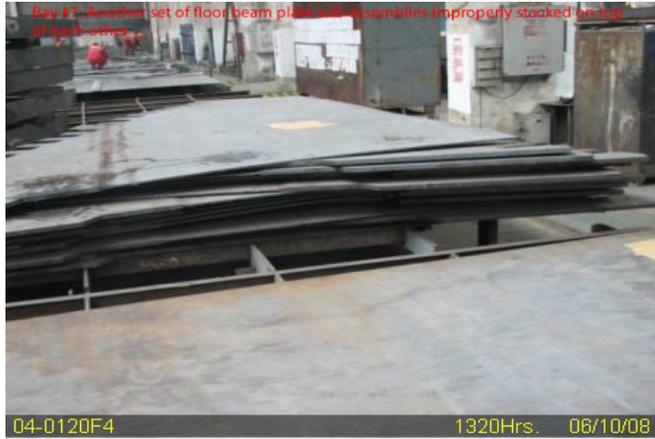
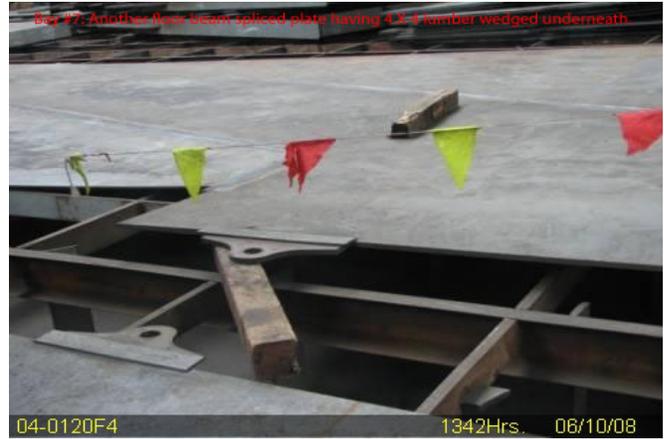
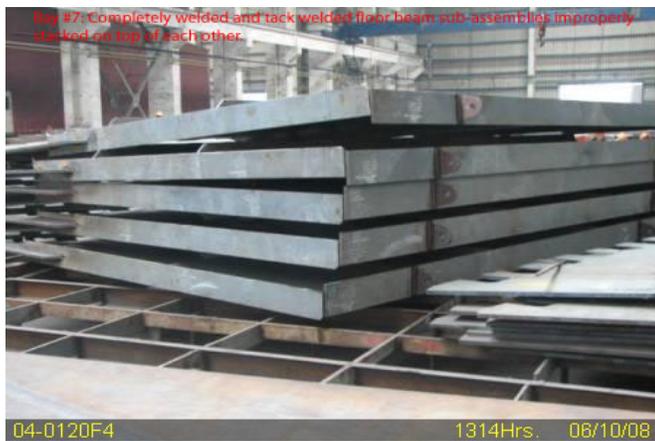
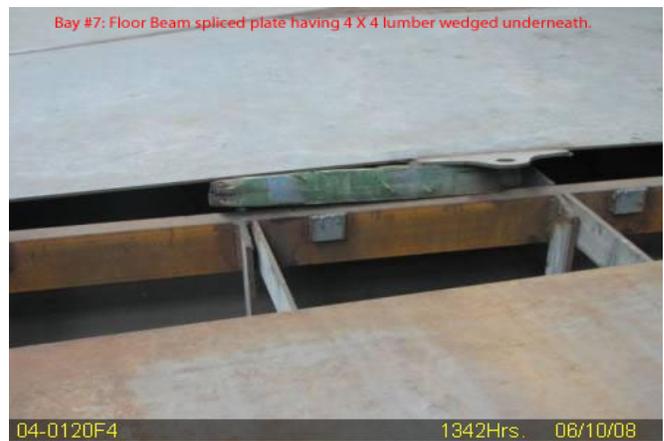
This QA observed completely welded and tack welded floor beam sub-assemblies are being improperly stacked on top of each other making it possible for distortion/loss of flatness to these assemblies. On same location, two butt welded splice plates are wedged with 4x4 lumber at the edge of these plates, which could also bring the same problem mentioned above. This QA called the attention of ZPMC CWI Hu Wei Qing, one ABF Inspector on the floor and ABF Inspector Kevin Dye to look at these floor beam situation. They all agreed and said to let ZPMC fix this scenario. See photo below.
