**DEPARTMENT OF TRANSPORTATION**

Contract #: 04-0120F4Cty: SF/ALA Rte: 80 PM: 13.2/13.9File #: 69.28**WELDING INSPECTION REPORT****Resident Engineer:** Pursell, Gary**Address:** 333 Burma Road**City:** Oakland, CA 94607**Report No:** WIR-002908**Date Inspected:** 13-Jun-2008**Project Name:** SAS Superstructure**OSM Arrival Time:** 630**Prime Contractor:** American Bridge/Fluor Enterprises, a JV**OSM Departure Time:** 1530**Contractor:** Zhenhua Port Machinery Company, Ltd (ZPMC), Changxing Island **Location:** Shanghai, China

## WELDING INSPECTION REPORT

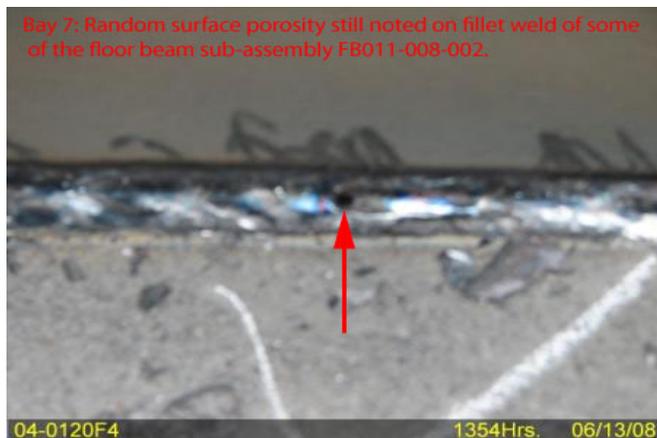
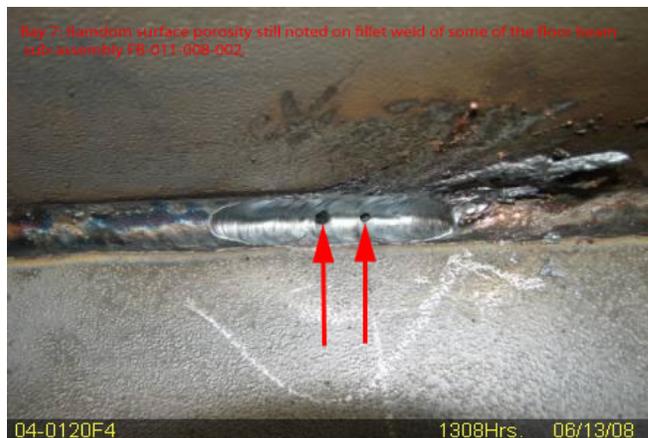
FCAW fillet welding (2F) was observed on stiffener to web plate on various floor beam sub-assemblies FB016-008-022 and FB016-008-021. ZPMC welders working on these were identified as Zhuo Jibo ID# 065564 and Lia Kai Ge ID #044830. ZPMC CWI Hu Wei Qing was noted monitoring the parameters. Tack welding/fit-up was continuing on stiffener to web plate of floor beam FB015-006-011/012 and FB015-006-015/016 using electrode TL-508. During tack welding/fit-up of these sub-assemblies, paint coating was removed, close and tight gap noted and preheating was used. FCAW 1G PJP welding was also continuing on critical weld repair B-CWR090 on longitudinal shear plate LD010-001-012 utilizing WPS-B-T-2231-Tc-U4b-F-1 by two ZPMC welders Chen Chuanzong and Wong Hong Lei. On floor beam FB011-008-002, random surface porosity was still noted on fillet weld between web plate and flange. See photo below.
