**DEPARTMENT OF TRANSPORTATION**

Contract #: 04-0120F4Cty: SF/ALA Rte: 80 PM: 13.2/13.9File #: 69.28**WELDING INSPECTION REPORT****Resident Engineer:** Pursell, Gary**Address:** 333 Burma Road**City:** Oakland, CA 94607**Report No:** WIR-002925**Date Inspected:** 27-May-2008**Project Name:** SAS Superstructure**OSM Arrival Time:** 1400**Prime Contractor:** American Bridge/Fluor Enterprises, a JV**OSM Departure Time:** 400**Contractor:** Zhenhua Port Machinery Company, Ltd (ZPMC), Changxing Island **Location:** Shanghai, China**CWI Name:** Chen Xi**CWI Present:** Yes No**Inspected CWI report:** Yes No N/A**Rod Oven in Use:** Yes No N/A**Electrode to specification:** Yes No N/A**Weld Procedures Followed:** Yes No N/A**Qualified Welders:** Yes No N/A**Verified Joint Fit-up:** Yes No N/A**Approved Drawings:** Yes No N/A**Approved WPS:** Yes No N/A**Delayed / Cancelled:** Yes No N/A**Bridge No:** 34-0006**Component:** OBG**Summary of Items Observed:**

# WELDING INSPECTION REPORT

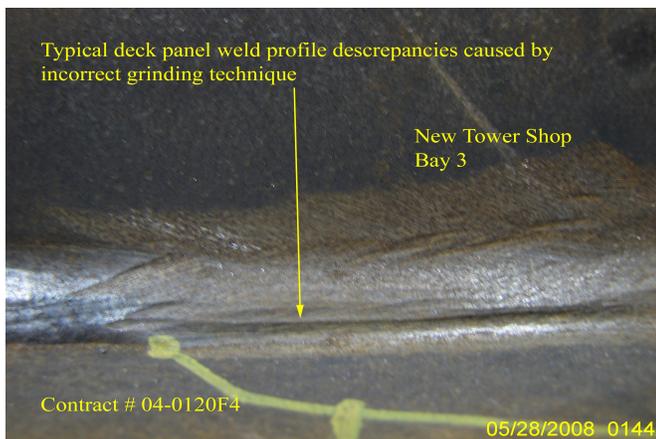
have ZPMC personnel remove surface rust from the weld repair areas with grinder using a wire wheel. The QA performed a visual inspection of the weld repairs and found numerous weld repairs which had been repaired using a grinder at the toe of the weld and removing the smooth transition from the weld to the base metal causing a 90 degree edge to be formed which produced an incorrect weld profile.

The QA Inspector informed Mr. Wang Lu, and Mr. Fu Yuhong and they both agreed that these repairs appeared unacceptable, and that ZPMC would correct the weld profile discrepancies. The QA Inspector informed both Mr. Fu Hong and Mr. Wang Lu that in the future, all request for Caltrans to witness a final MT on deck panels must have already have ZPMC QC final visual completed.
