DEPARTMENT OF TRANSPORTATION

Contract #: 04-0120F4Cty: SF/ALA Rte: 80 PM: 13.2/13.9File #: 69.28**WELDING INSPECTION REPORT****Resident Engineer:** Pursell, Gary**Address:** 333 Burma Road**City:** Oakland, CA 94607**Report No:** WIR-002976**Date Inspected:** 06-Jun-2008**Project Name:** SAS Superstructure**OSM Arrival Time:** 700**Prime Contractor:** American Bridge/Fluor Enterprises, a JV**OSM Departure Time:** 1700**Contractor:** Zhenhua Port Machinery Company, Ltd (ZPMC), Changxing Island **Location:** Shanghai, China**CWI Name:** Sun Wei**CWI Present:** Yes No**Inspected CWI report:** Yes No N/A**Rod Oven in Use:** Yes No N/A**Electrode to specification:** Yes No N/A**Weld Procedures Followed:** Yes No N/A**Qualified Welders:** Yes No N/A**Verified Joint Fit-up:** Yes No N/A**Approved Drawings:** Yes No N/A**Approved WPS:** Yes No N/A**Delayed / Cancelled:** Yes No N/A**Bridge No:** 34-0006**Component:** OBG**Summary of Items Observed:**

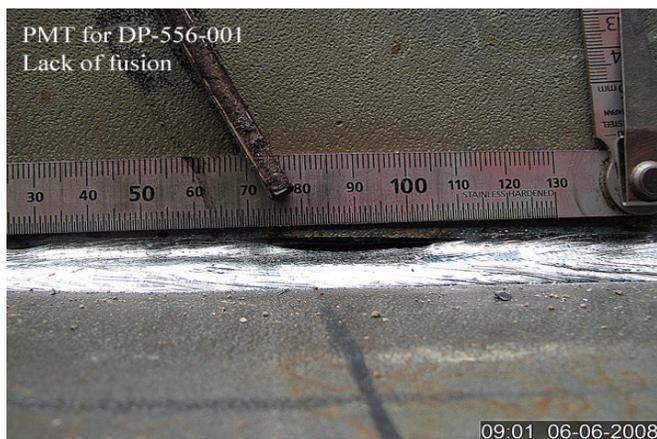
ZPMC Quality Control performed visual inspection of the GMAW weld pass and the subsequent SAW weld pass. ZPMC QC noted a weld as visually non-compliant due to lack of fusion exceeding the 25 millimeter tolerance. ZPMC relayed they would perform a second PMT. Below is a digital photograph illustrating the lack of fusion observed.

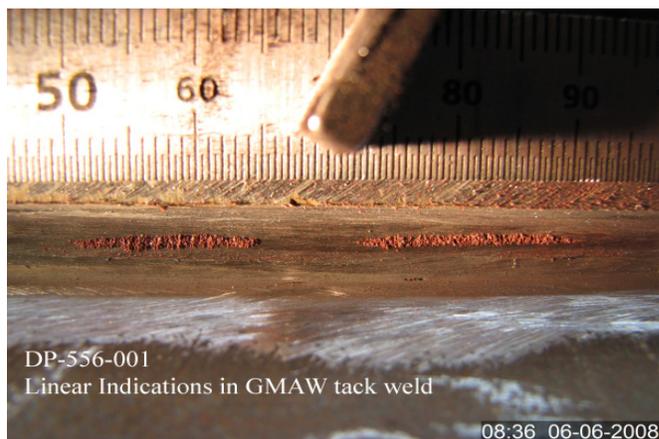
Deck Panel DP-556-001

ZPMC relayed no magnetic particle testing was going to be performed to the GMAW tack welds prior to welding the root pass on Deck Panel DP-556-001. The Quality Assurance Inspector performed magnetic particle inspection to 100 percent of welds 1 and 10. Of the 49 tack welds inspected 24 appeared to contain linear crack like indications. Below is a digital photograph illustrating one of the cracked tack welds. ZPMC marked the welds for repair and later repaired the tack welds by grinding and re-testing by the magnetic particle testing method.
