DEPARTMENT OF TRANSPORTATION

Quality Assurance and Source Inspection

Contract #: 04-0120F4Cty: SF/ALA Rte: 80 PM: 13.2/13.9File #: 69.28**WELDING INSPECTION REPORT****Resident Engineer:** Pursell, Gary**Address:** 333 Burma Road**City:** Oakland, CA 94607**Report No:** WIR-002978**Date Inspected:** 20-Jun-2008**Project Name:** SAS Superstructure**OSM Arrival Time:** 1430**Prime Contractor:** American Bridge/Fluor Enterprises, a JV**OSM Departure Time:** 2230**Contractor:** Zhenhua Port Machinery Company, Ltd (ZPMC), Changxing Island **Location:** Shanghai, China**CWI Name:** Fu Yuhoung**CWI Present:** Yes No**Inspected CWI report:** Yes No N/A**Rod Oven in Use:** Yes No N/A**Electrode to specification:** Yes No N/A**Weld Procedures Followed:** Yes No N/A**Qualified Welders:** Yes No N/A**Verified Joint Fit-up:** Yes No N/A**Approved Drawings:** Yes No N/A**Approved WPS:** Yes No N/A**Delayed / Cancelled:** Yes No N/A**Bridge No:** 34-0006**Component:** OBG**Summary of Items Observed:**

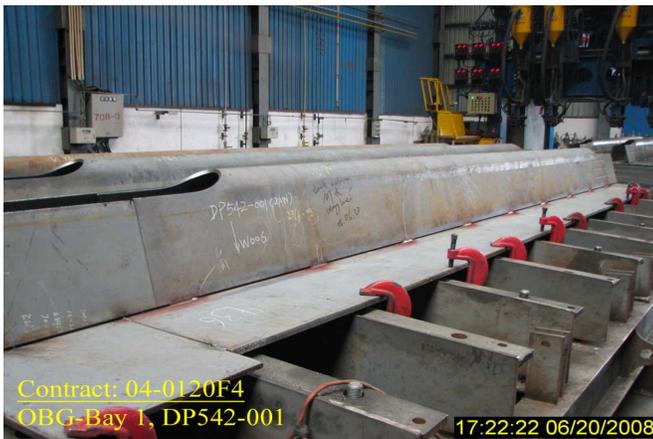
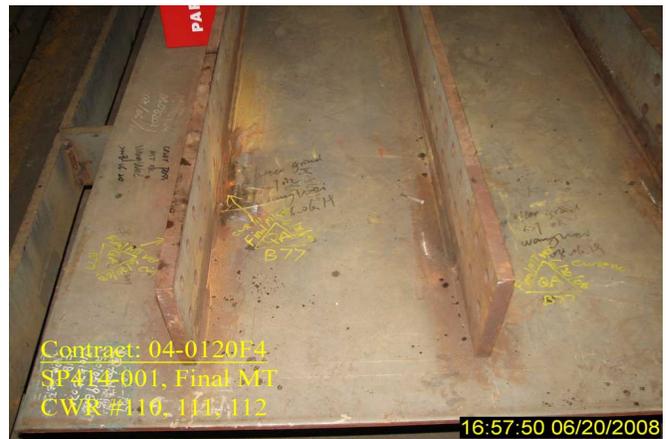
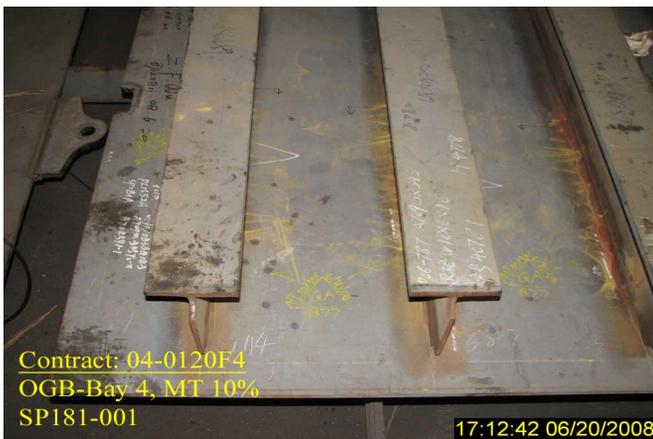
Also in this bay, the QA Inspector observed the following deck panels located on gantry 1; DP582-001 (in-process), DP542-001 (idle), DP602-001 (complete), DP607-001 (complete). The QA Inspector observed DP331-001 (idle) located on gantry 2.

QA observed ZPMC has approximately 57 workers performing various functions relative to the fabrication of the OBG Deck Panels. These functions include; closed rib press forming, hole drilling at ends of U-Ribs using a drill template, PJP bevel preparation, closed rib splice FCAW welding, closed rib diaphragm fit-up and FCAW welding, closed rib to deck plate fit-up and tack welding.
