**DEPARTMENT OF TRANSPORTATION**

Contract #: 04-0120F4Cty: SF/ALA Rte: 80 PM: 13.2/13.9File #: 99.28**WELDING INSPECTION REPORT****Resident Engineer:** Pursell, Gary**Address:** 333 Burma Road**City:** Oakland, CA 94607**Report No:** WIR-002985**Date Inspected:** 16-Jun-2008**Project Name:** SAS Superstructure**OSM Arrival Time:** 2230**Prime Contractor:** American Bridge/Fluor Enterprises, a JV**OSM Departure Time:** 830**Contractor:** Japan Steel Works, Ltd.**Location:** Muroran, Japan**CWI Name:** Makhmud Ashadi**CWI Present:** Yes No**Inspected CWI report:** Yes No N/A**Rod Oven in Use:** Yes No N/A**Electrode to specification:** Yes No N/A**Weld Procedures Followed:** Yes No N/A**Qualified Welders:** Yes No N/A**Verified Joint Fit-up:** Yes No N/A**Approved Drawings:** Yes No N/A**Approved WPS:** Yes No N/A**Delayed / Cancelled:** Yes No N/A**Bridge No:** 34-0006**Component:** Tower, Jacking and Deviation Saddles**Summary of Items Observed:**

## WELDING INSPECTION REPORT

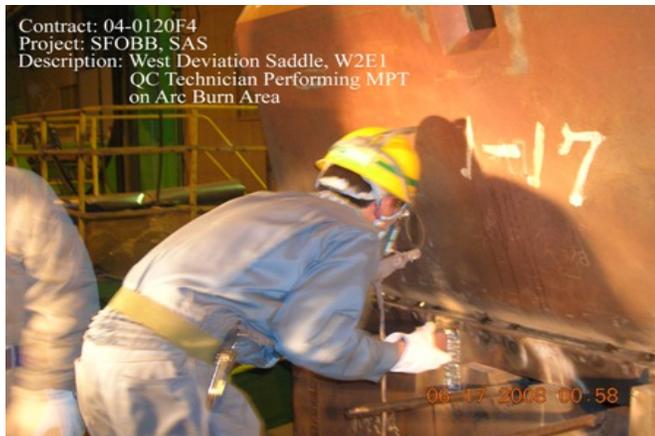
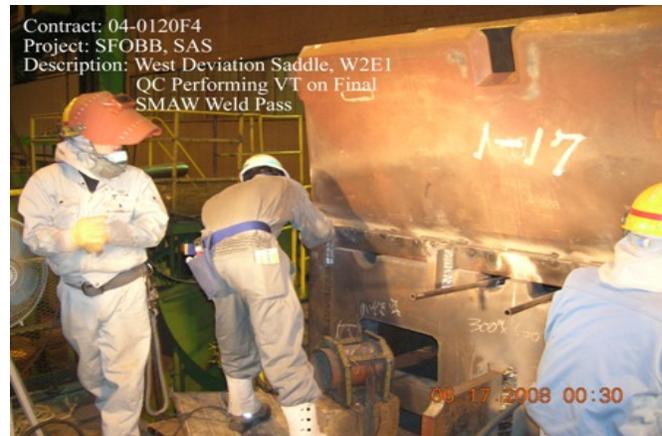
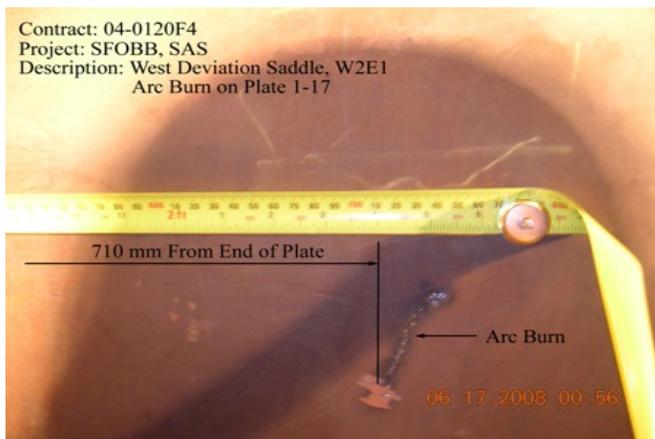
The following digital photographs illustrate the observations of the activities performed on this date.
