DEPARTMENT OF TRANSPORTATION

Contract #: 04-0120F4Cty: SF/ALA Rte: 80 PM: 13.2/13.9File #: 69.28**WELDING INSPECTION REPORT****Resident Engineer:** Pursell, Gary**Address:** 333 Burma Road**City:** Oakland, CA 94607**Report No:** WIR-003001**Date Inspected:** 06-Jun-2008**Project Name:** SAS Superstructure**OSM Arrival Time:** 630**Prime Contractor:** American Bridge/Fluor Enterprises, a JV**OSM Departure Time:** 1730**Contractor:** Zhenhua Port Machinery Company, Ltd (ZPMC), Changxing Island **Location:** Shanghai, China**CWI Name:** Fu Yu Hong**CWI Present:** Yes No**Inspected CWI report:** Yes No N/A**Rod Oven in Use:** Yes No N/A**Electrode to specification:** Yes No N/A**Weld Procedures Followed:** Yes No N/A**Qualified Welders:** Yes No N/A**Verified Joint Fit-up:** Yes No N/A**Approved Drawings:** Yes No N/A**Approved WPS:** Yes No N/A**Delayed / Cancelled:** Yes No N/A**Bridge No:** 34-0006**Component:** OBG**Summary of Items Observed:**

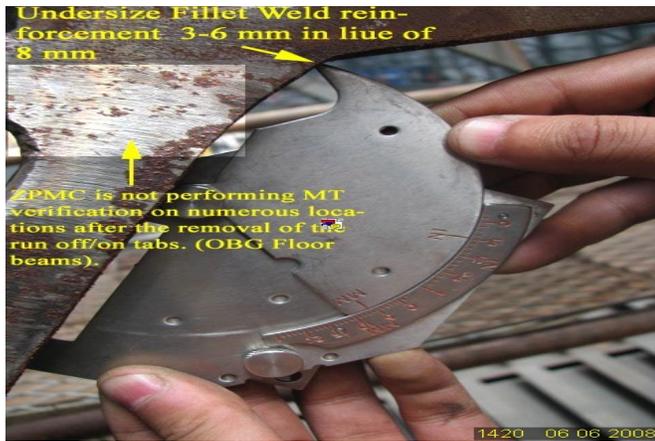
The QA inspector performed random visual weld inspection to the floorbeam FL-2-1 connections. The QA inspector found weld undersized (required fillet weld reinforcement 8 mm as per approved weld detail drawings) at the junction of the connection plate to the bottom flange from the floor beam FL-2-1 at the following locations: SSD19A-PP024-133(5 mm fillet weld reinforcement), SSD19-PP024-136(4 mm fillet weld reinforcement), SSD16-PP020-005(3 mm fillet weld reinforcement), SSD16A-PP020-132(4-5 mm fillet weld reinforcement), SSD19A-PP023-137(3mm fillet weld reinforcement)and SSD19A-PP023-133(3 mm fillet weld reinforcement). The QA inspector had a conversation with ABF representative Peter Shaw. The QA inspector brought to his attention that: 1. Several welds were undersized at the junction of connection plates to bottom flange on the floor beam FL-2-1, 2. ZPMC had weld defects overlooked by ZPMC QC to be repairs at the floor beam connection and 3. ZPMC had not performed magnetic particle inspection at the ends of those connection after the removal of the

run-off tacks. Mr. Peter Shaw agreed. The QA inspector informed Mr. Peter Shaw that the QA inspector was going to recommend an incident report to be written on this matter.
