**DEPARTMENT OF TRANSPORTATION**

Contract #: 04-0120F4Cty: SF/ALA Rte: 80 PM: 13.2/13.9File #: 69.28**WELDING INSPECTION REPORT****Resident Engineer:** Pursell, Gary**Address:** 333 Burma Road**City:** Oakland, CA 94607**Report No:** WIR-003025**Date Inspected:** 30-May-2008**Project Name:** SAS Superstructure**OSM Arrival Time:** 1400**Prime Contractor:** American Bridge/Fluor Enterprises, a JV**OSM Departure Time:** 2300**Contractor:** Zhenhua Port Machinery Company, Ltd (ZPMC), Changxing Island **Location:** Shanghai, China

**Bridge No:** 34-0006**Component:** OBG side and bottom panels, tower skin plate**Summary of Items Observed:**

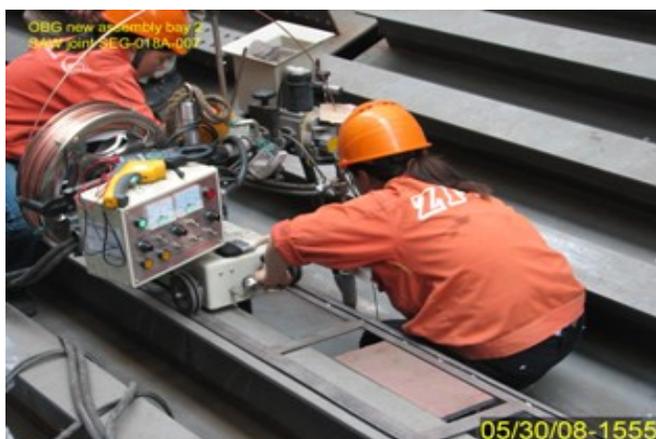
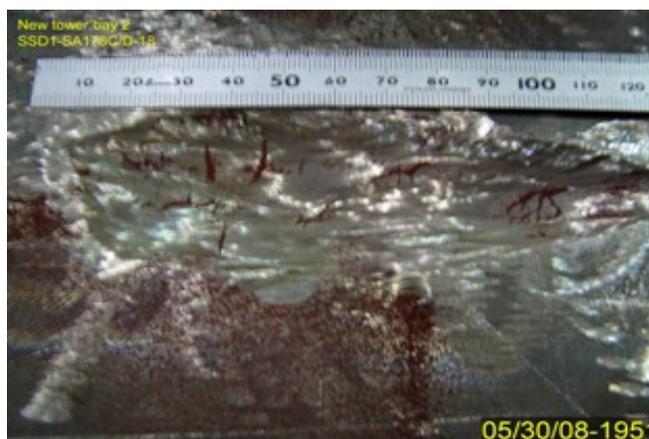
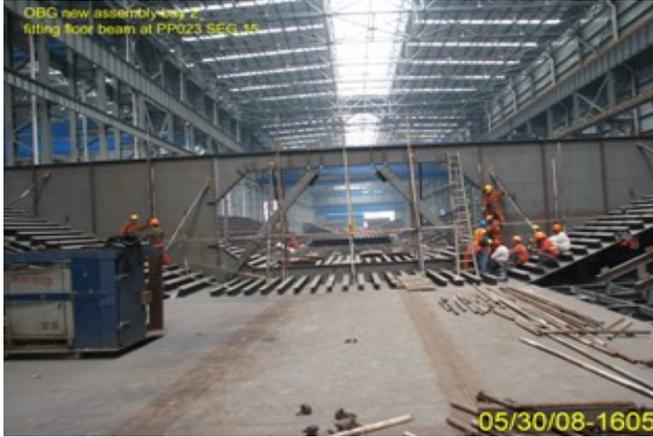
ZPMC Quality Control (QC) inspectors discovered an 80mm long crack in tower skin plate weld joint SSD1-SA178C/D-18. ZPMC elected to excavate the affected area to a depth of approximately 16 – 18mm x 120mm in length x 30mm wide. The excavation was Magnetic particle Tested (MT) by QA for information only and found to contain what appeared to be several transverse and several longitudinal indications. ZPMC QC notified Caltrans QA of this condition and is apparently submitting a Critical Weld Repair (CWR) procedure concerning this issue.
