**DEPARTMENT OF TRANSPORTATION**

Contract #: 04-0120F4Cty: SF/ALA Rte: 80 PM: 13.2/13.9File #: 69.28**WELDING INSPECTION REPORT****Resident Engineer:** Pursell, Gary**Address:** 333 Burma Road**City:** Oakland, CA 94607**Report No:** WIR-003084**Date Inspected:** 10-Jun-2008**Project Name:** SAS Superstructure**OSM Arrival Time:** 1430**Prime Contractor:** American Bridge/Fluor Enterprises, a JV**OSM Departure Time:** 2300**Contractor:** Zhenhua Port Machinery Company, Ltd (ZPMC), Changxing Island **Location:** Shanghai, China**CWI Name:** Li Yan Hua**CWI Present:** Yes No**Inspected CWI report:** Yes No N/A**Rod Oven in Use:** Yes No N/A**Electrode to specification:** Yes No N/A**Weld Procedures Followed:** Yes No N/A**Qualified Welders:** Yes No N/A**Verified Joint Fit-up:** Yes No N/A**Approved Drawings:** Yes No N/A**Approved WPS:** Yes No N/A**Delayed / Cancelled:** Yes No N/A**Bridge No:** 34-0006**Component:** OBG Deck Panels**Summary of Items Observed:**

**Bay 3--New Tower Building**

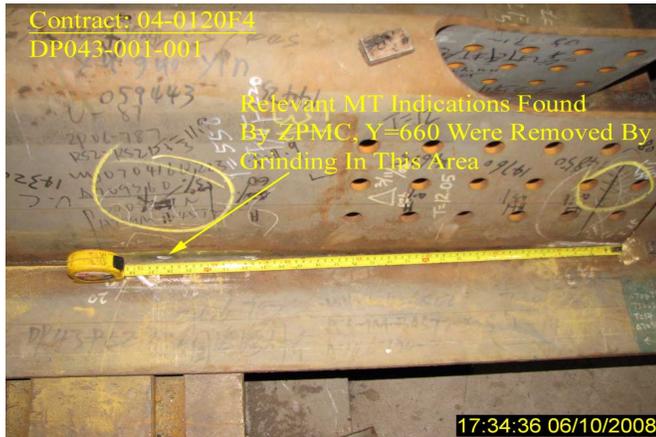
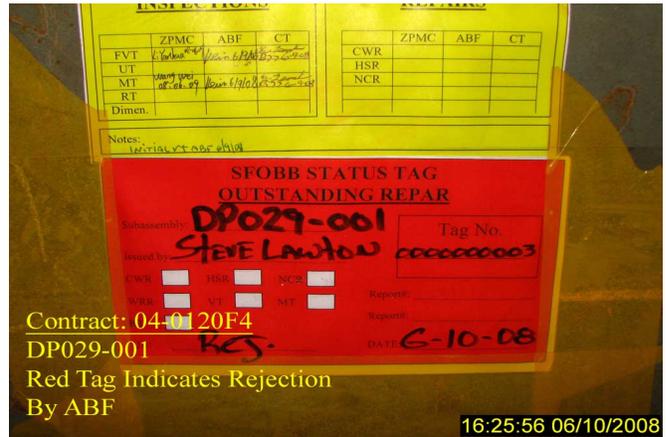
Later in the shift the QA Inspector observed ZPMC personnel Wang Wei perform final magnetic particle testing (MT) after repairs on DP043-001. Upon completion of MT inspection, ZPMC personnel found relevant indications located on weld joint designation 001 at 660 mm Y. The QA Inspector, along with ABF QC personnel

Kevin Chen, witnessed ZPMC personnel perform grinding to remove the indications and verify complete removal with MT verification. After grinding the QA Inspector measured the excavation at 15mm length and 1.5mm in depth. The QA Inspector was informed by ABF QC personnel Kevin Chen that the area will be repaired by welding, ground and re-inspected by MT once the repair is complete. Mr. Chen also informed the QA Inspector that the final VT and MT inspections by ZPMC, ABF and Caltrans will resume tomorrow morning (6/11/08) on DP043-001.
