DEPARTMENT OF TRANSPORTATION

Contract #: 04-0120F4Cty: SF/ALA Rte: 80 PM: 13.2/13.9File #: 69.28**WELDING INSPECTION REPORT****Resident Engineer:** Pursell, Gary**Address:** 333 Burma Road**City:** Oakland, CA 94607**Report No:** WIR-003161**Date Inspected:** 02-Jul-2008**Project Name:** SAS Superstructure**OSM Arrival Time:** 630**Prime Contractor:** American Bridge/Fluor Enterprises, a JV**OSM Departure Time:** 1530**Contractor:** Zhenhua Port Machinery Company, Ltd (ZPMC), Changxing Island **Location:** Shanghai, China

WELDING INSPECTION REPORT

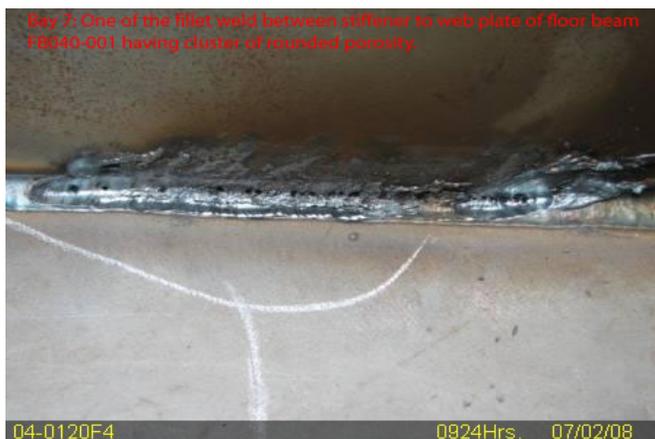
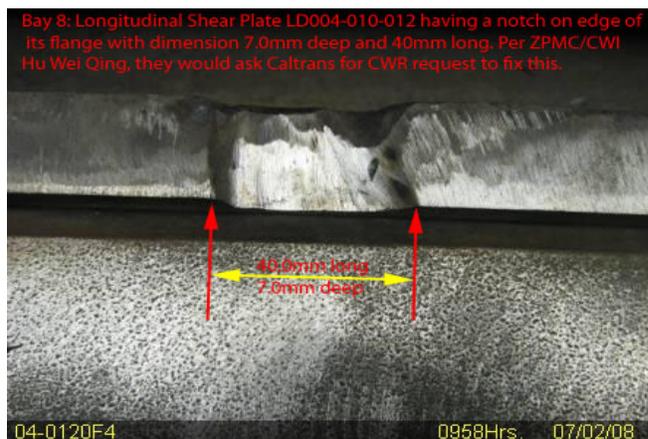
The QA Inspector randomly observed ZPMC welder Liu Yu Jun ID Number 202654, utilizing the Flux Cored Arc Welding (FCAW) Process in the 1G (Flat Groove) Position with ZPMC WPS WPS-B-T-2231-B-U2-F, to weld the fill pass on PJP corner joint between flange and web plate on longitudinal shear plate LD003-013-012. The QA Inspector randomly observed ZPMC CWI Hu We Qing. This QA also noted longitudinal shear plate LD004-010-012 flange having notch 7.0mm deep and 40mm long. Since this notch is quite significant, ZPMC CWI Hu We Qing said that ZPMC would make CWR request to Caltrans to fix this notch. See photo below.
