DEPARTMENT OF TRANSPORTATION

Contract #: 04-0120F4Cty: SF/ALA Rte: 80 PM: 13.2/13.9File #: 69.28**WELDING INSPECTION REPORT****Resident Engineer:** Pursell, Gary**Address:** 333 Burma Road**City:** Oakland, CA 94607**Report No:** WIR-003165**Date Inspected:** 28-Jun-2008**Project Name:** SAS Superstructure**OSM Arrival Time:** 700**Prime Contractor:** American Bridge/Fluor Enterprises, a JV**OSM Departure Time:** 1500**Contractor:** Zhenhua Port Machinery Company, Ltd (ZPMC), Changxing Island **Location:** Shanghai, China**CWI Name:** Sun Wei**CWI Present:** Yes No**Inspected CWI report:** Yes No N/A**Rod Oven in Use:** Yes No N/A**Electrode to specification:** Yes No N/A**Weld Procedures Followed:** Yes No N/A**Qualified Welders:** Yes No N/A**Verified Joint Fit-up:** Yes No N/A**Approved Drawings:** Yes No N/A**Approved WPS:** Yes No N/A**Delayed / Cancelled:** Yes No N/A**Bridge No:** 34-0006**Component:** OBG and Tower**Summary of Items Observed:**

OBG Sub-Assembly Bay 1**Deck Panel Production Welding**

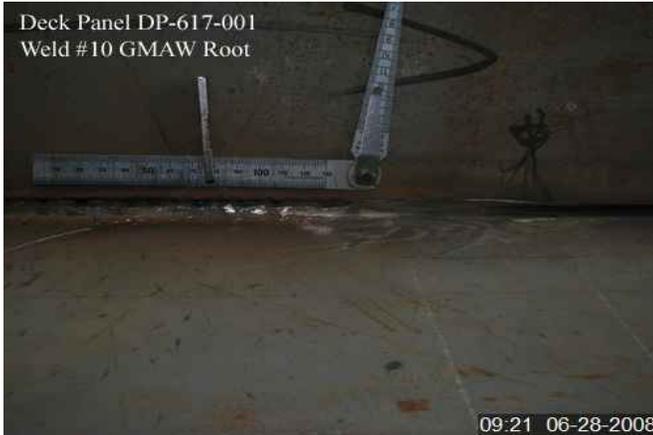
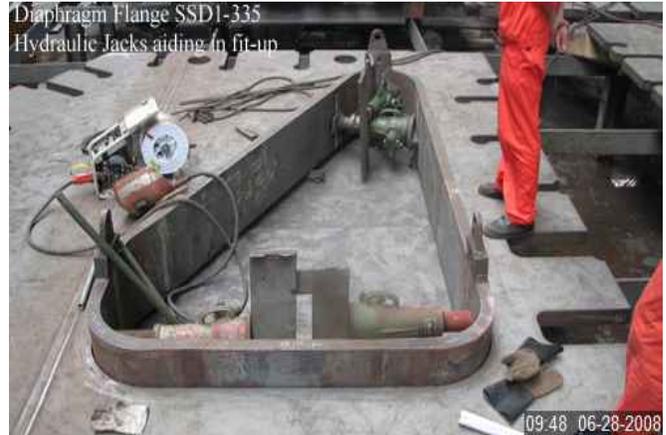
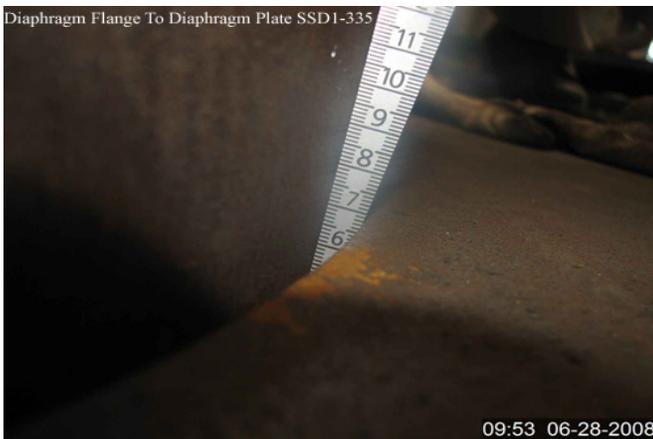
ZPMC utilized 4 mechanical jacking devices to aid in the fit-up of Diaphragm Flange at Diaphragm Plate SSD1-335. ZPMC was using three 50 ton jacks and a 32 ton jack in an effort to close up to a 7mm gap between the flange and the diaphragm plate. Below are digital photographs illustrating the jacks and the gap.
