**DEPARTMENT OF TRANSPORTATION**

Contract #: 04-0120F4Cty: SF/ALA Rte: 80 PM: 13.2/13.9File #: 69.28**WELDING INSPECTION REPORT****Resident Engineer:** Pursell, Gary**Address:** 333 Burma Road**City:** Oakland, CA 94607**Report No:** WIR-003194**Date Inspected:** 29-Jun-2008**Project Name:** SAS Superstructure**OSM Arrival Time:** 1400**Prime Contractor:** American Bridge/Fluor Enterprises, a JV**OSM Departure Time:** 2300**Contractor:** Zhenhua Port Machinery Company, Ltd (ZPMC), Changxing Island **Location:** Shanghai China

# WELDING INSPECTION REPORT

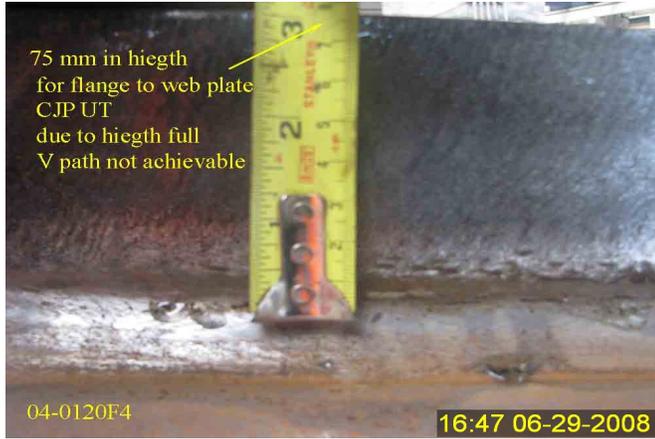
This Quality Assurance (QA) inspector arrived at ZPMC in Shanghai China for observation of Orthotropic Bridge Girders (OBG) and Self Anchored Suspension (SAS) Bridge. This QA inspector received notification of witness inspection for non destructive testing after ZPMC personnel had completed their testing. In tower shop bay 1 this QA inspector performed Ultrasonic Testing (UT) verifications for 10 % of the complete weld lengths listed. Skin plate A final UT weld numbers NSD1-SA159 D/J 3A and 4A on 90 mm thick plates with a total weld length of 2710 mm. Upon completion of the verification it was noted the weldments were within compliance as per AWS D1.5. Also tested was skin plate C UT after repairs weld numbers SSD1-SA179 D/E 30 A/B, SSD1-SA179 D/E 27 A/B, SSD1-SA179 D/E 28 A/B and SSD1-SA179 E/E 4 A/B average weld length for these locations was approximately 600 mm with a material thickness transmission of 60 mm to 90 mm. Upon completion of the verification it was noted the weldments were within compliance as per AWS D1.5. Bay 7, UT verification was performed by this QA inspector on component number FB009-006-043 for CJP weldment of web plate to flange complete V path was not achievable due to material height. Scanning from both A and B side was performed. Testing was performed in the first leg this QA inspector found no rejectable indications for the 10% verified. A TL-6028 will be generated for these locations.
