Contract #: 04-0120F4Cty: SF/ALA Rte: 80 PM: 13.2/13.9File #: 69.28**WELDING INSPECTION REPORT****Resident Engineer:** Pursell, Gary**Address:** 333 Burma Road**City:** Oakland, CA 94607**Report No:** WIR-003208**Date Inspected:** 14-Jul-2008**Project Name:** SAS Superstructure**OSM Arrival Time:** 630**Prime Contractor:** American Bridge/Fluor Enterprises, a JV**OSM Departure Time:** 1530**Contractor:** Zhenhua Port Machinery Company, Ltd (ZPMC), Changxing Island **Location:** Shanghai, China**CWI Name:** C.M. Chen**CWI Present:** Yes No**Inspected CWI report:** Yes No N/A**Rod Oven in Use:** Yes No N/A**Electrode to specification:** Yes No N/A**Weld Procedures Followed:** Yes No N/A**Qualified Welders:** Yes No N/A**Verified Joint Fit-up:** Yes No N/A**Approved Drawings:** Yes No N/A**Approved WPS:** Yes No N/A**Delayed / Cancelled:** Yes No N/A**Bridge No:** 34-0006**Component:** OBG**Summary of Items Observed:**

WELDING INSPECTION REPORT

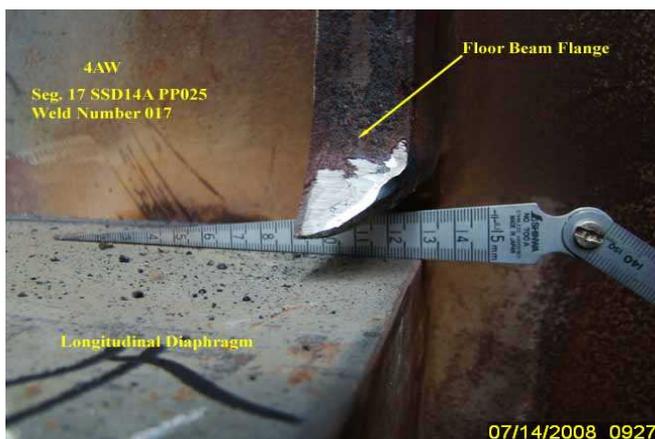
OBG Assembly Segment 4AW- Caltrans QA observed ZPMC having completed tack welding complete on all longitudinal diaphragm located on Seg. 17 SSD14/14A, PP 025. This Caltrans QA observed Floor Beam FB015-02 flange plate that attaches to longitudinal diaphragm LD 002 having a root opening of 11mm. The allowable root opening on ZPMC's WPS is 5mm. In a conversation with ZPMC CWI Bao Lei a ZPMC welding repair report will be written in order to resolve this issue. See attached photograph for additional information.
