DEPARTMENT OF TRANSPORTATION

Contract #: 04-0120F4Cty: SF/ALA Rte: 80 PM: 13.2/13.9File #: 69.28**WELDING INSPECTION REPORT****Resident Engineer:** Pursell, Gary**Address:** 333 Burma Road**City:** Oakland, CA 94607**Report No:** WIR-003232**Date Inspected:** 14-Jul-2008**Project Name:** SAS Superstructure**OSM Arrival Time:** 1400**Prime Contractor:** American Bridge/Fluor Enterprises, a JV**OSM Departure Time:** 2300**Contractor:** Zhenhua Port Machinery Company, Ltd (ZPMC), Changxing Island **Location:** Shanghai, China

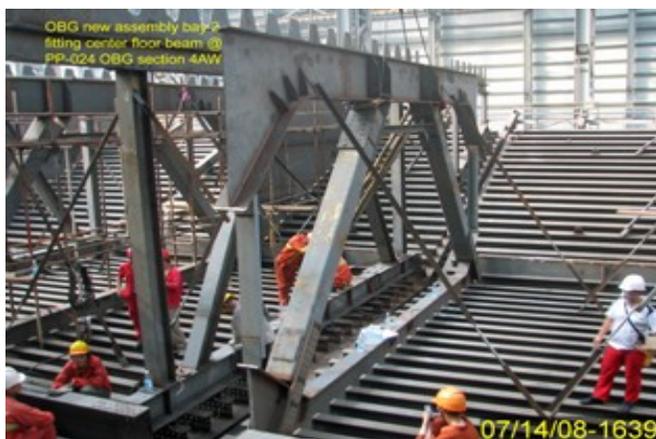
QA observed ZPMC personnel fitting floor beam center section @ PP-024 OBG section 4AW. See attached photo.
