DEPARTMENT OF TRANSPORTATION

Contract #: 04-0120F4Cty: SF/ALA Rte: 80 PM: 13.2/13.9File #: 69.28**WELDING INSPECTION REPORT****Resident Engineer:** Pursell, Gary**Address:** 333 Burma Road**City:** Oakland, CA 94607**Report No:** WIR-003242**Date Inspected:** 17-Jul-2008**Project Name:** SAS Superstructure**OSM Arrival Time:** 630**Prime Contractor:** American Bridge/Fluor Enterprises, a JV**OSM Departure Time:** 1530**Contractor:** Zhenhua Port Machinery Company, Ltd (ZPMC), Changxing Island **Location:** Shanghai, China

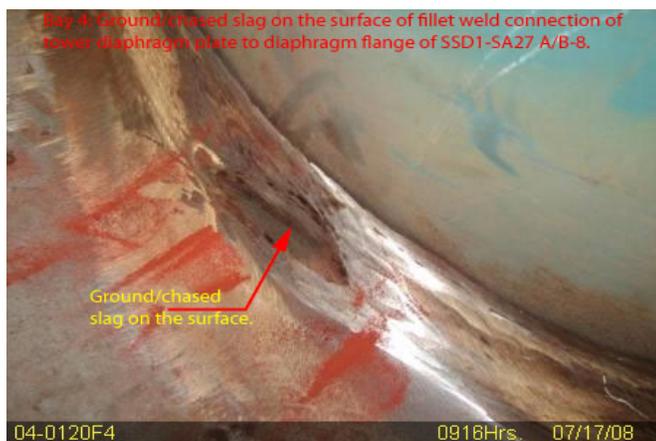
This QA observed ZPMC/QC perform 100% MT on fillet weld connection between tower diaphragm plate to diaphragm flange SSD1-SA27 A/B-8. While ZPMC was doing the MT, one of the ABF/QA found a slag on the surface of the fillet weld, which ZPMC tried to remove by grinding. The ground area of the fillet became deep and the required size was already inadequate. Per ZPMC, they will fix this by welding then do the MT again after repair. See photo below.

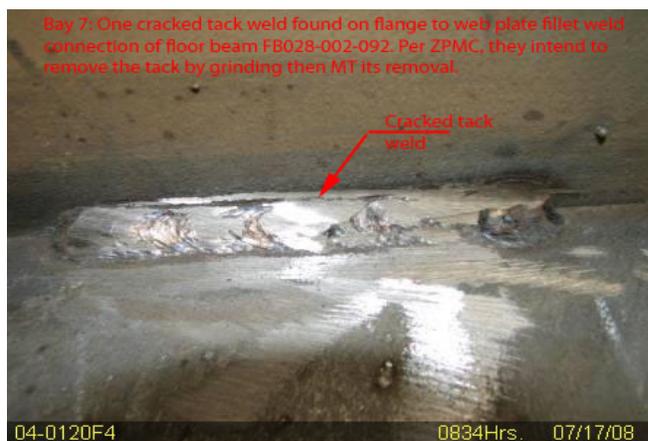
FCAW fillet welding (2F) was observed on flange to web plate of longitudinal shear plate LD004-020-011. ZPMC welder working on this was identified as Meny Tao ID# 068918. ZPMC CWI Hu Wei Qing was noted monitoring the parameters. Tack welding/fit-up of flange to web plate of longitudinal shear plate using TL-508 by ZPMC welder Li Wen Guo ID #066261 this QA also observed. On one tack welded flange to web plate fillet weld connection of floor beam FB028-002-092, one tack weld was noted by ABF/QA Inspector to have cracked. ZPMC/CWI Huang Wen Pang called this QA to confirm the existence of cracked tack weld. Though no MT was done prior to see the tack weld, it was obvious from visual itself. Per ZPMC, they intend to remove this tack by grinding then MT its removal. See photo below.
