DEPARTMENT OF TRANSPORTATION

Contract #: 04-0120F4Cty: SF/ALA Rte: 80 PM: 13.2/13.9File #: 69.28**WELDING INSPECTION REPORT****Resident Engineer:** Pursell, Gary**Address:** 333 Burma Road**City:** Oakland, CA 94607**Report No:** WIR-003282**Date Inspected:** 07-Jul-2008**Project Name:** SAS Superstructure**OSM Arrival Time:** 2300**Prime Contractor:** American Bridge/Fluor Enterprises, a JV**OSM Departure Time:** 730**Contractor:** Zhenhua Port Machinery Company, Ltd (ZPMC), Changxing Island **Location:** Changxing Island**CWI Name:** Chen Chih Meng**CWI Present:** Yes No**Inspected CWI report:** Yes No N/A**Rod Oven in Use:** Yes No N/A**Electrode to specification:** Yes No N/A**Weld Procedures Followed:** Yes No N/A**Qualified Welders:** Yes No N/A**Verified Joint Fit-up:** Yes No N/A**Approved Drawings:** Yes No N/A**Approved WPS:** Yes No N/A**Delayed / Cancelled:** Yes No N/A**Bridge No:** 34-0006**Component:** OBG**Summary of Items Observed:**

Caltrans Quality Assurance (QA) Inspector, Larry Viars was present to monitor activities associated with the Production Monitoring Test of Orthotropic Box Girder (OBG) components, for the San Francisco Oakland Bay Self Anchored Suspe

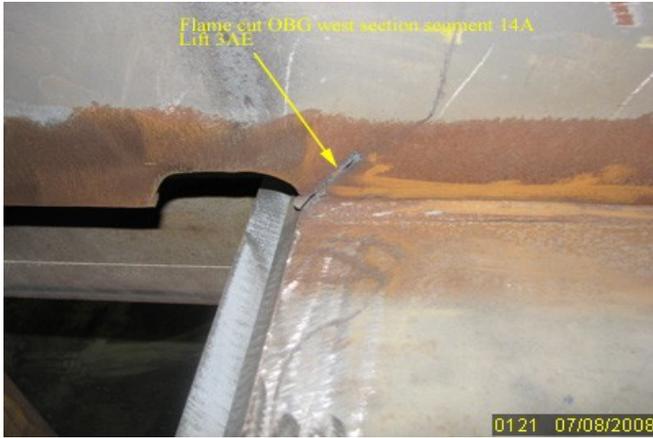
The Caltrans QA Inspector observed base metal repair welding of Segment 14A lift 4AE bevel face (B-WR536). ZPMC welder Mr. Wanglin Jiang performed Flux Cored Arc Welding (FCAW) in the 1G position. The above mentioned repair procedure was a dual repair for the bevel face as well as the flame cut areas of the stiffeners. Only weld build up was performed on the bevel face. The repair procedure called for 5 to 6 mm of additional weld from the dimension listed on shop drawings. Welding appeared to be in conformance with AWS D1.5 (2002) and the posted Welding Procedure Specification, WPS-345-FCAW-1G (1F) FCM Repair. Please see photo of the flame cut area on stiffener.
